**IVECO**  
CERTIFIED PRE-OWNED

# Vehicle Return Guidelines

This damage catalogue aims to prepare you for returning your IVECO vehicle when your usage period comes to an end.

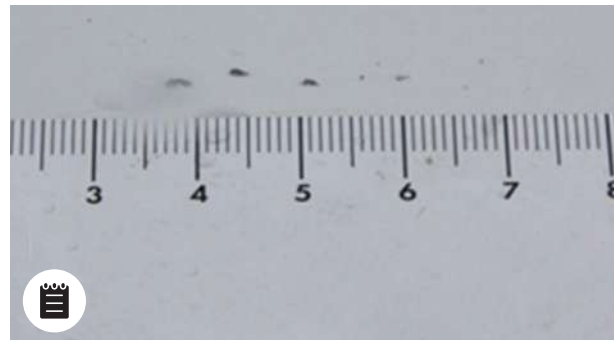
Chip  $\leq 5$  mm in diameter and  $\leq 20$  chips

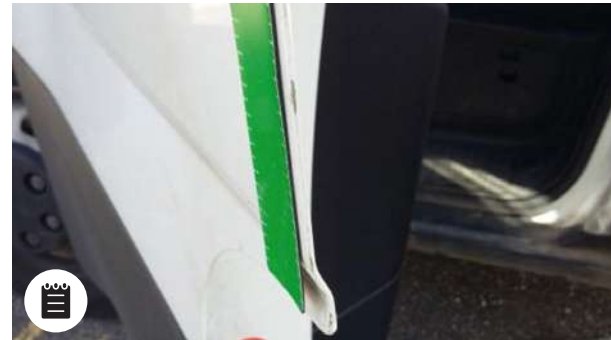
Chip on door edge

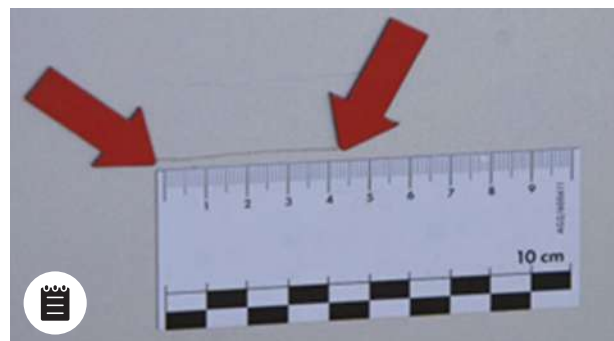
Polishable damage or scratch  $\leq 50$  mm

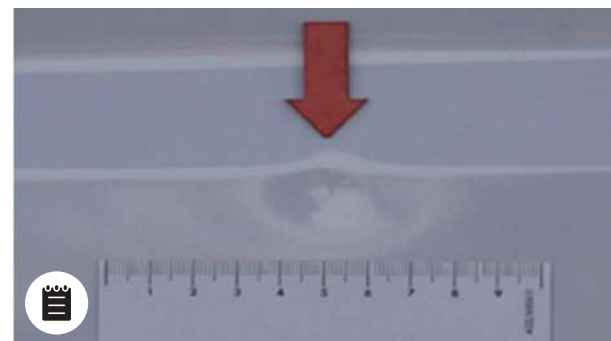
Indentations  $\leq 20$  mm in diameter with unaltered paint, no hail damage and significant pockmarks within the limit of 5 indentations per panel

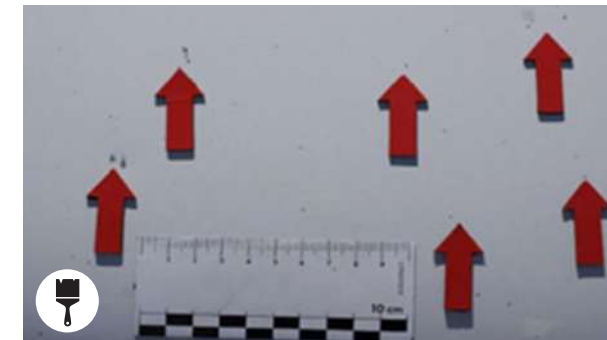
Chip  $> 5$  mm or  $> 20$  chips

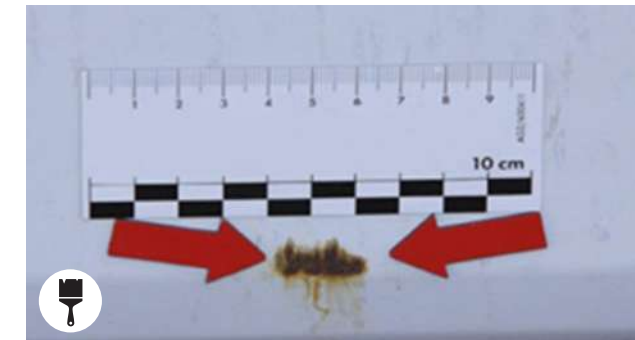
Scratches with oxidation, chemical deposit or other that cannot be cleaned

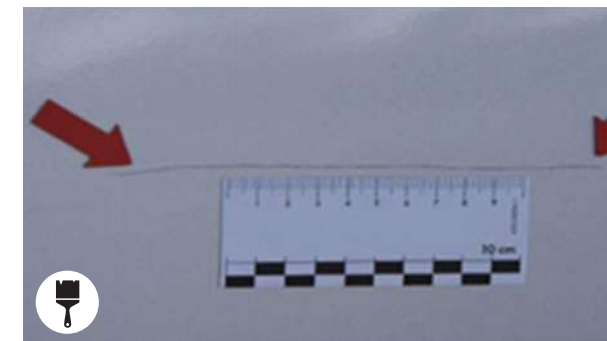
Scratches  $> 20$  mm

**Note:** On rear swinging door it is not possible to paint per half panel

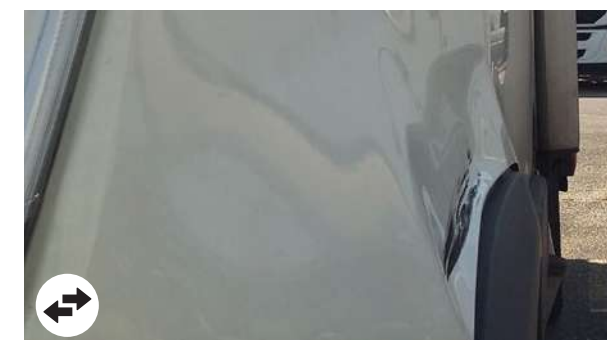
Irreparable parts, beyond economic repair or non-compliant exchanged part

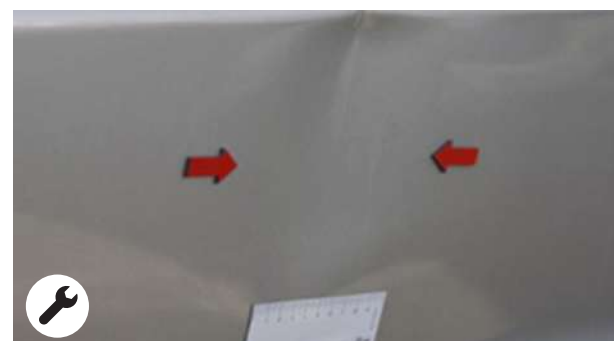
Indentations > 20 mm in diameter; altered paint, hail damage or significant pockmarks  
NB: Smart repair possible on isolated, significant pockmarks if paint is not altered

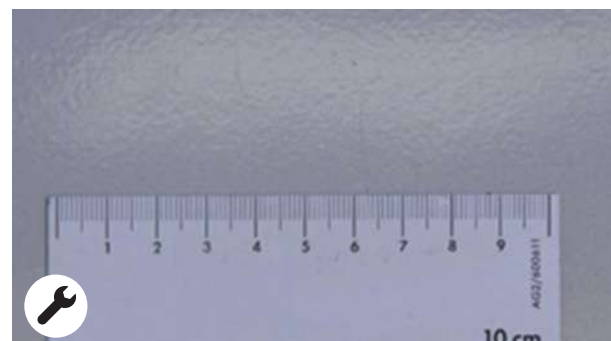
Repainted with fault (dimpled appearance). Paint too thick, insufficient, with inclusion of particles

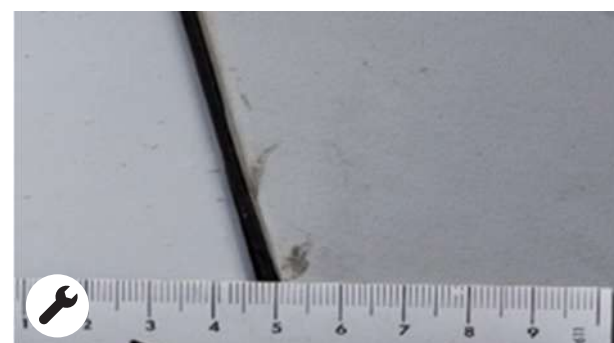
Difference in shade following repair  
NB: Tolerance accepted linked to ageing of the vehicle

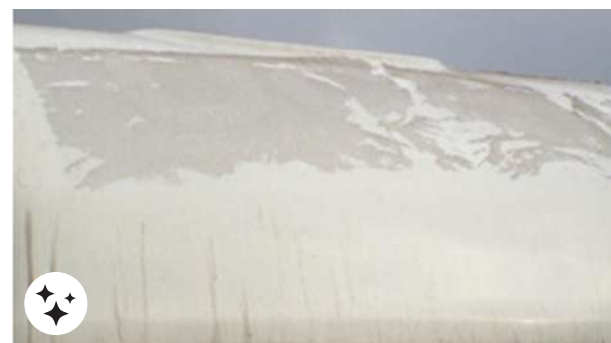
Trace of glue. NB: Presence of tags or graffiti, valuation in real time during cleaning and/or buffing

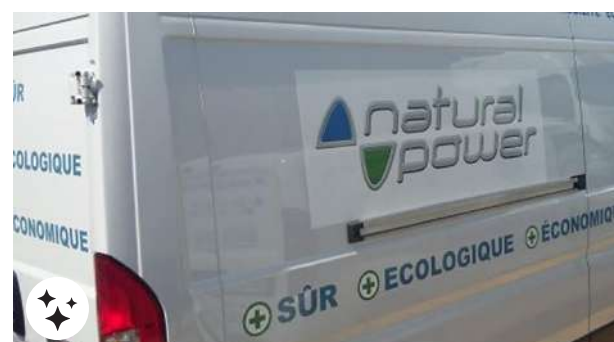
Marks left by advertisements following the description of the bodywork.

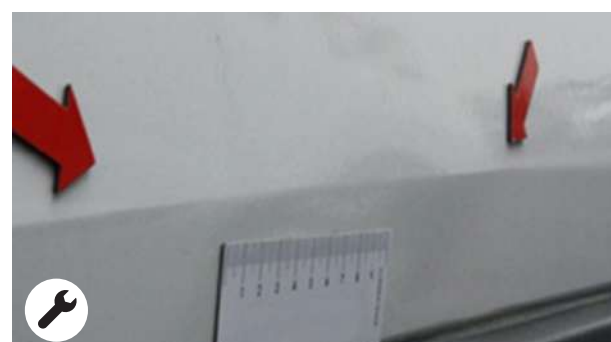
Defect: Deformed panel following repair

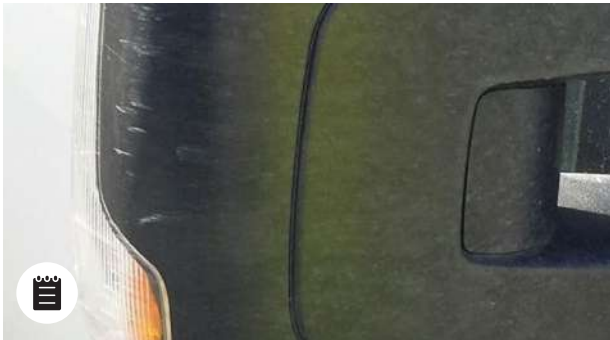
Scratches that cannot be felt with your nail and surface  $\leq 45 \text{ cm}^2$  (equivalent to a credit card)

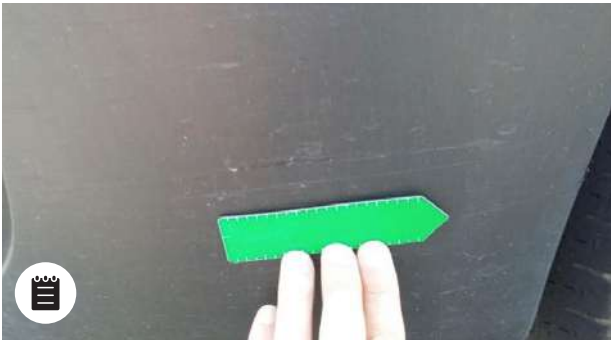
Scratches that can be felt with your nail or surface  $\leq 45 \text{ cm}^2$  (equivalent to a credit card)

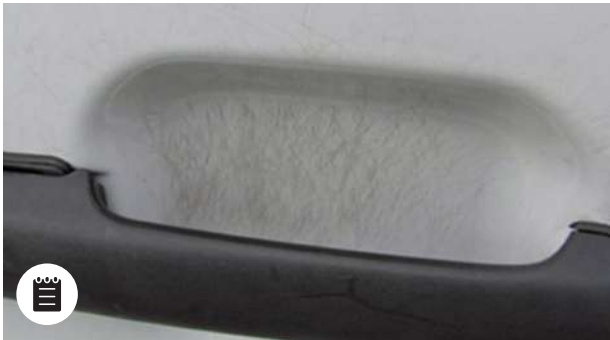
Faint superficial scratches, e.g at the fuel filler cap, hatches, door handles, bumpers and trims

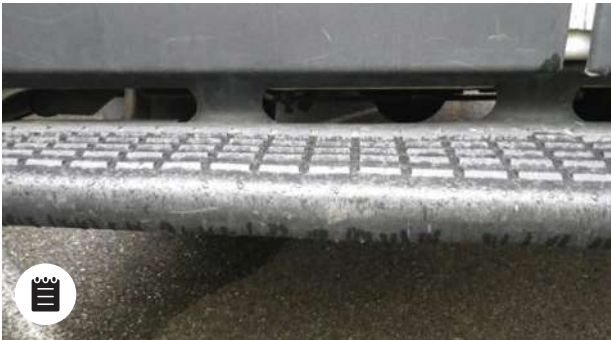
Faint scratches in the paint at the loading edges

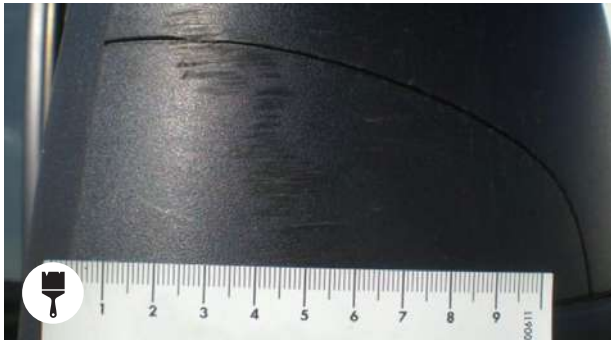
Scratches that can be felt with your nail or surface  $> 45 \text{ cm}^2$  (equivalent to a credit card)

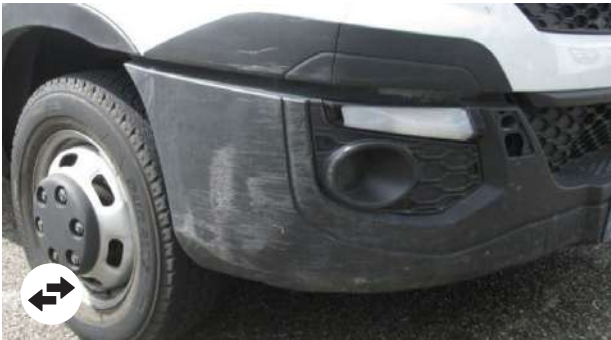
Removal of material or deformation feasible or economical to repair

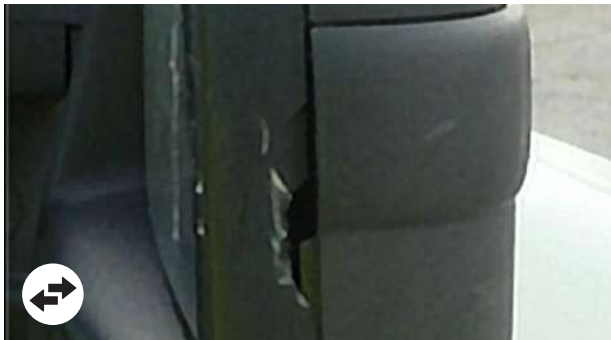
Removal of material, broken part

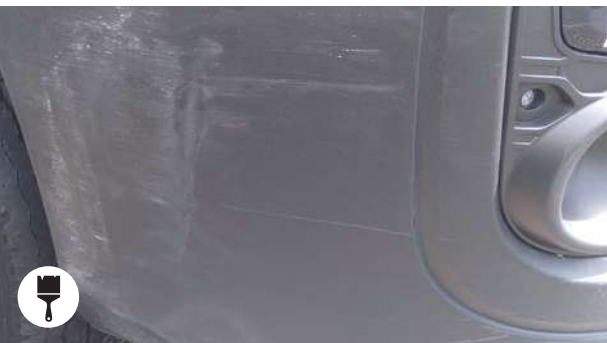
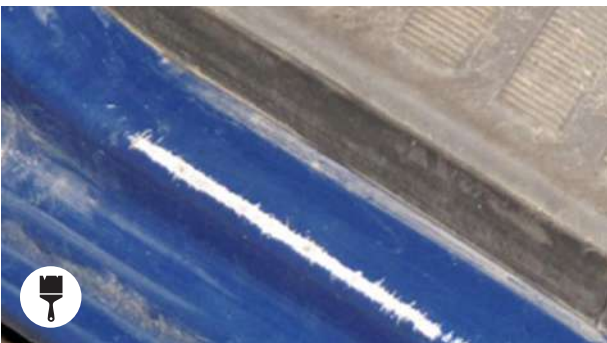
Scratches that can be felt with your nail and surface > 45 cm² (equivalent to a credit card)

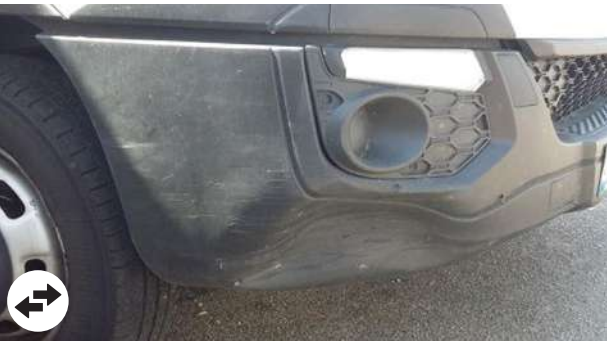
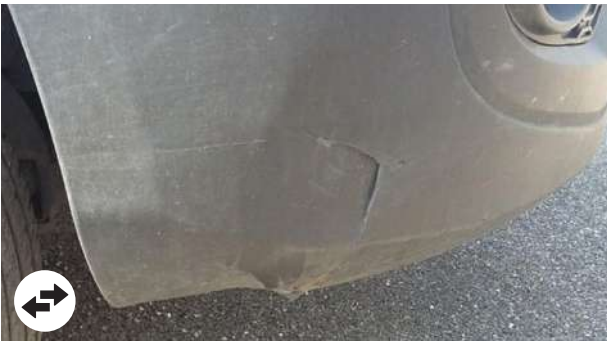
Broken, removal of material or deformation beyond economic repair or not feasible

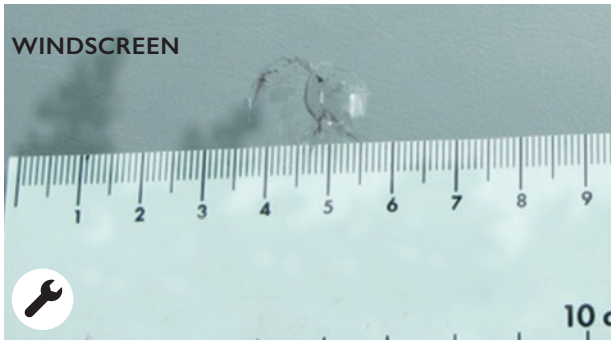
Chips ≤ 20 mm, outside of field of vision and ≤ 3 chips

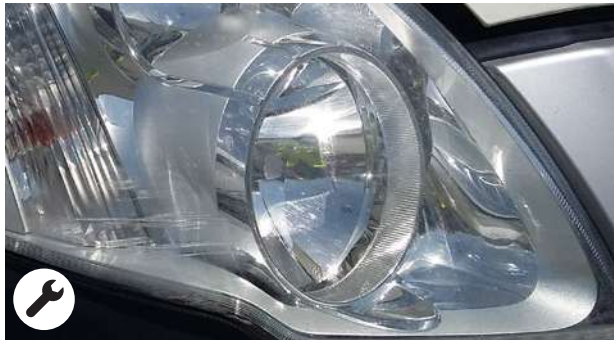
Faint scratch (without removal of material), outside of lighting field and sealed light (BUFFING)

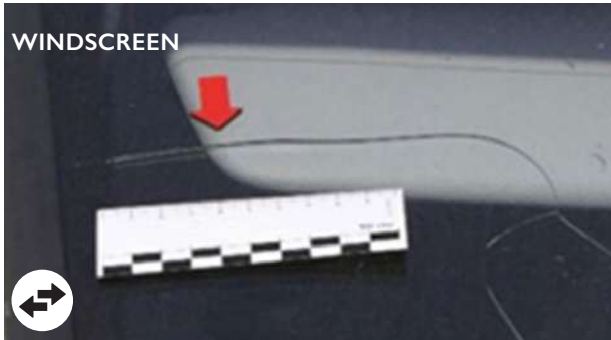
Chips > 20 mm, number > 3 chips, or chips in the field of vision, cracked, poorly fitted with defect, sandblasted or scratched  
**Note:** If the windshield is damaged in the driver's field of vision, local legislation must be checked.

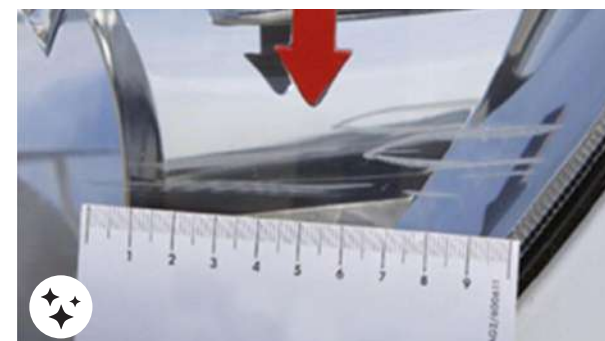
Deep scratch (with removal of material),  
outside of lighting field and sealed light

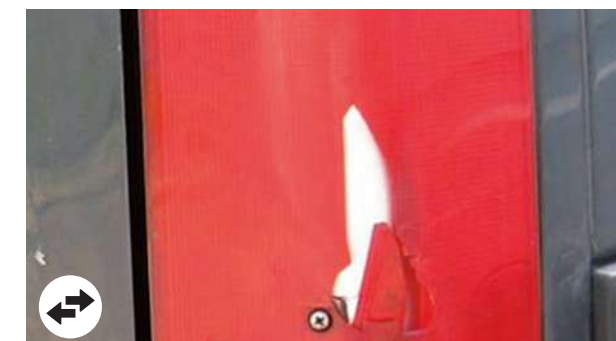
Rear and front lights broken

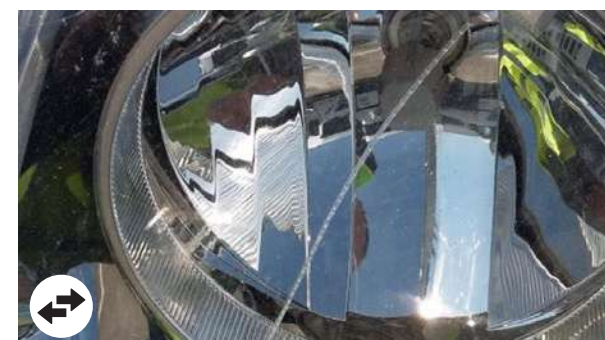
Scratch in the lighting field, crack, condensation, broken or broken fastening

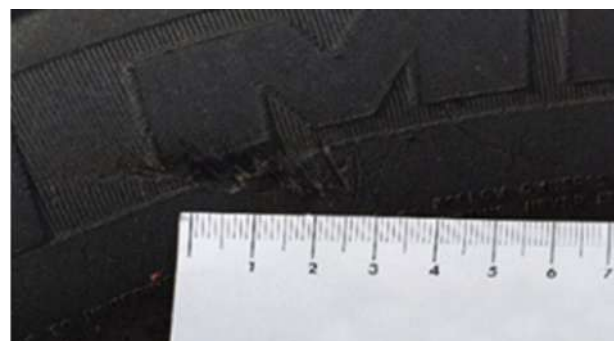
Tyres: Notch  $\leq$  3 mm deep (CONFORMS)

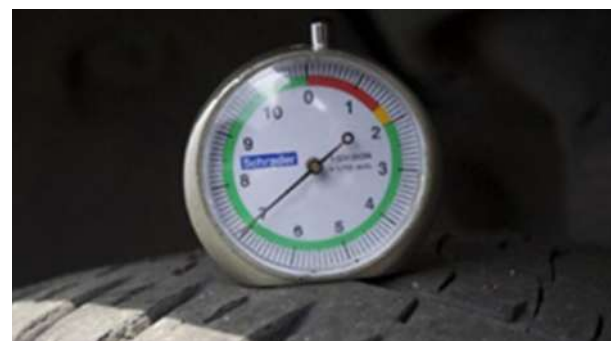
Tyres: Base of groove depth  $\geq$  5 mm (CONFORMS)  
**Note:** The wear of the tyres is measured in the most worn groove on the tyre.

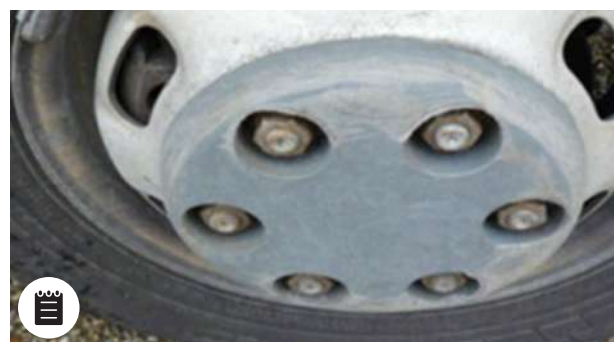
Rims and wheel covers: Multiple superficial scratches with or without removal of material

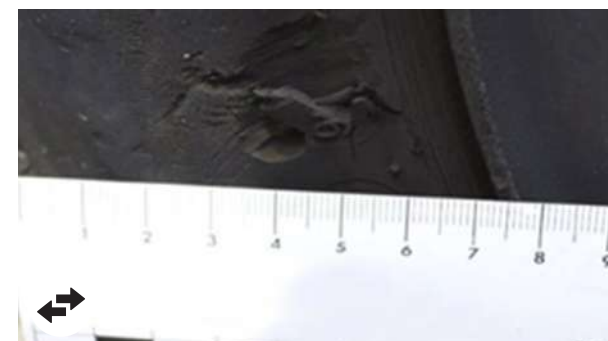
Tyres: Notch  $>$  3 mm deep, removal

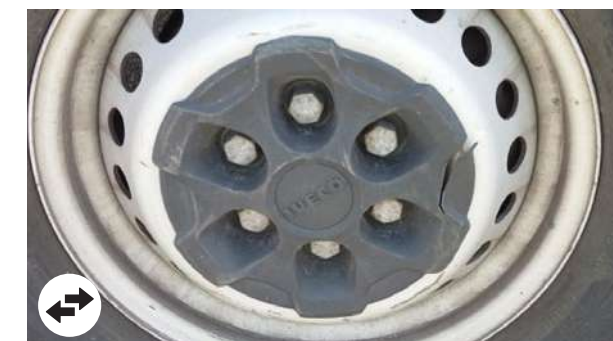
Wheel covers: Deformed, broken, material missing or removed

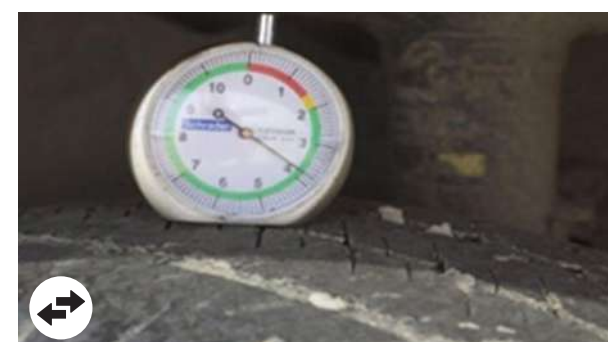
Tyres: Base of groove depth  $<$  5 mm  
**Note:** The wear of the tyres is measured in the most worn groove on the tyre.

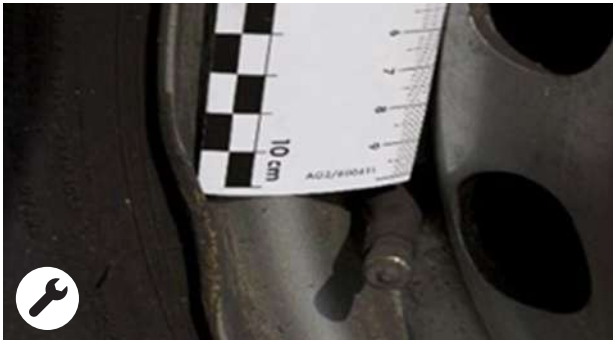
On steel rim: Attachment edge slightly deformed

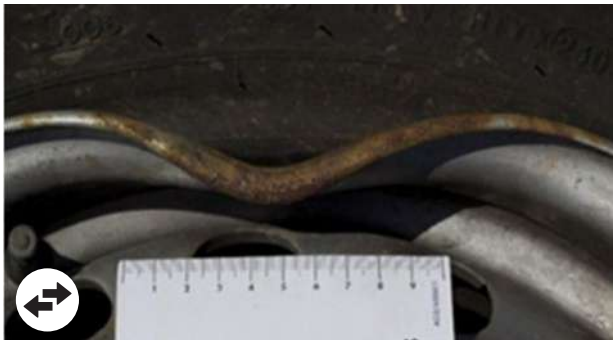
Wheel rim circumference, damaged non-compliant rim. Valuation of a dimensional check to check safe state of the vehicle

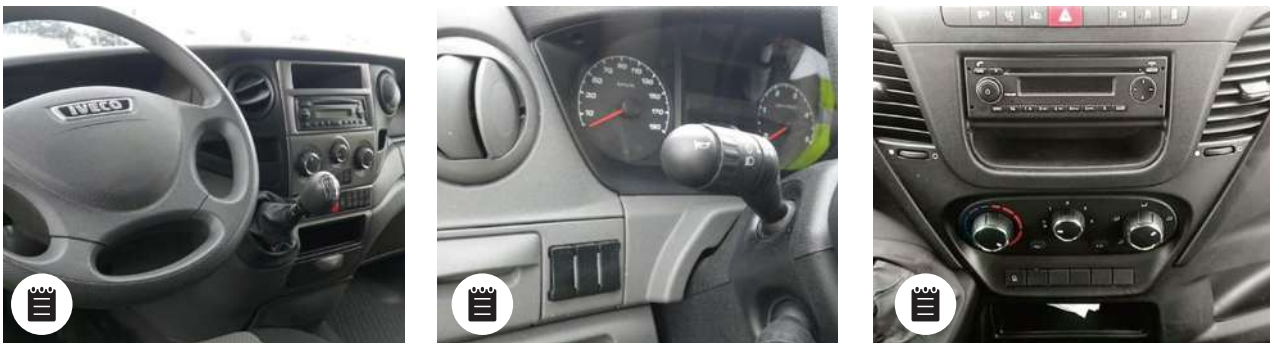
Traces of wear on the instrument panel, instrument cluster and steering wheel

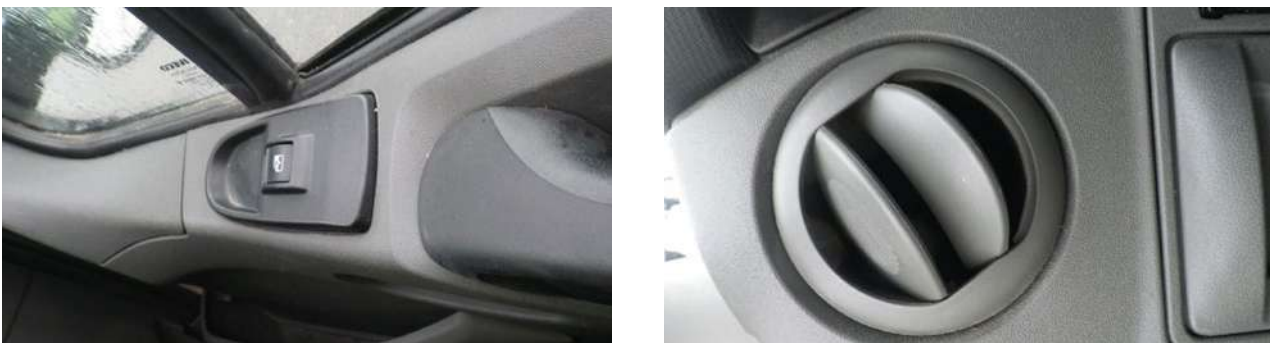
- Slight discolouration due to sun exposure
- Light soiling can be removed by chemical cleaning carried out by a professional

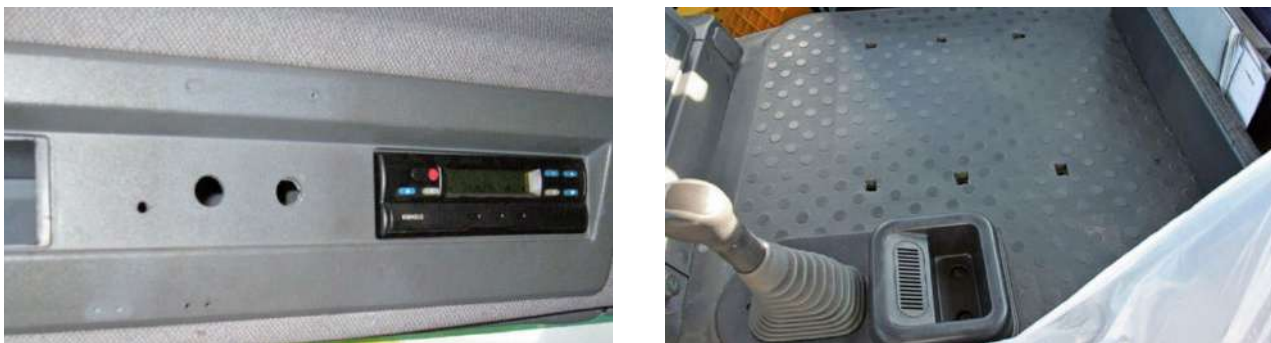
- Control parts, seat or trim pieces missing, broken or pierced
- Systems, seatbelt, seat control, displays and visuals not operating

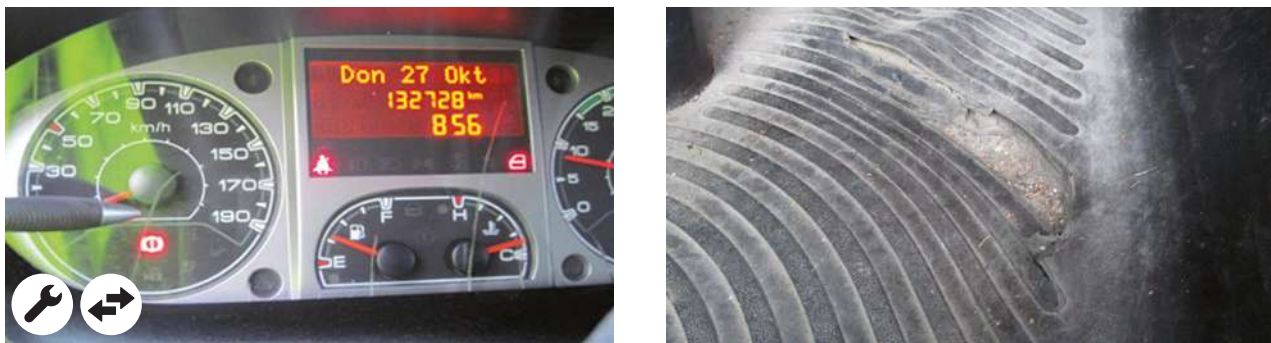
- Scratches on the combined instrument panel and other visuals or holes in the field of vision
- Significant soiling, stains and smells requiring chemical cleaning carried out by a professional.

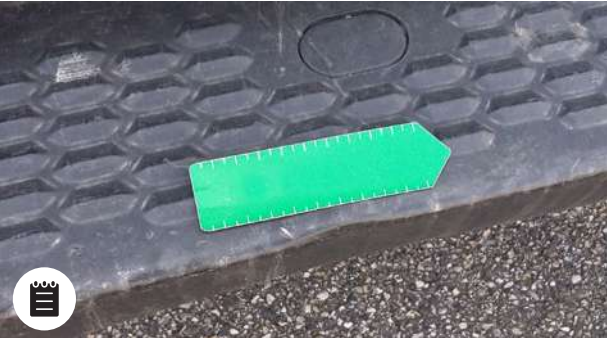
Rear Step Slight deformation

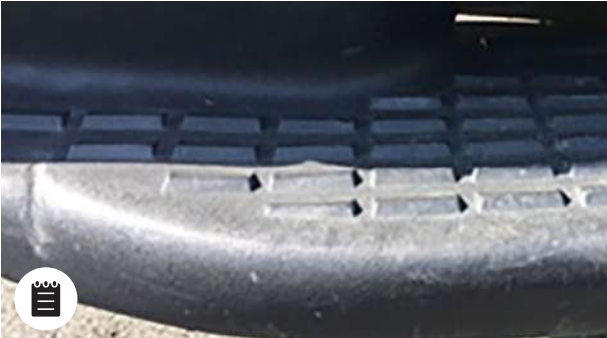
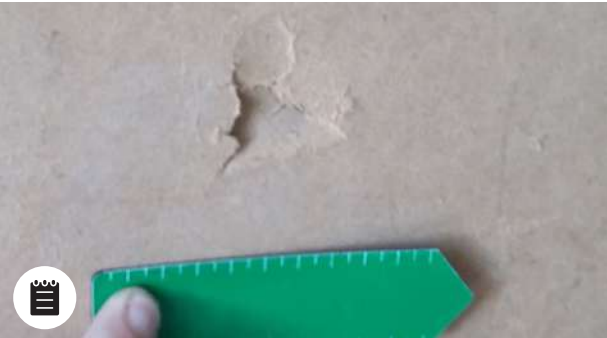
Wood internal protections: Small impacts

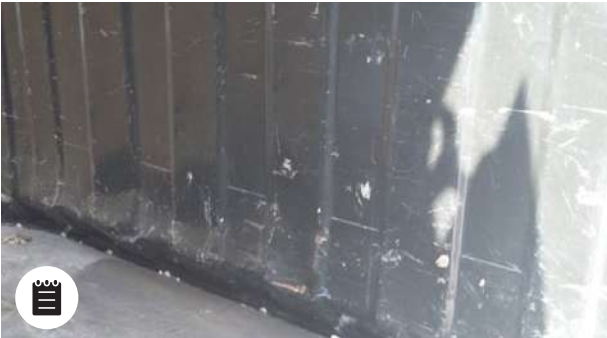
Internal deformations: Slight deformation without perforations or cuts, repair time  $\leq 3$  h

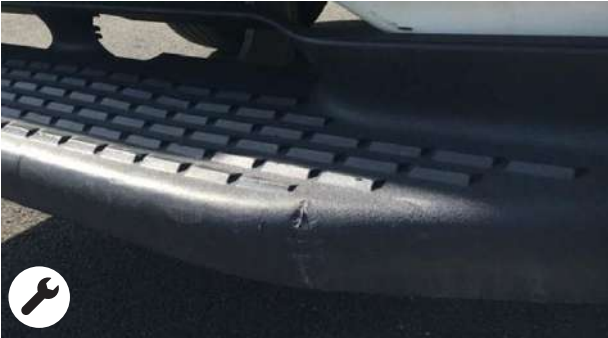
Rear footboards: Deformations within economic repair

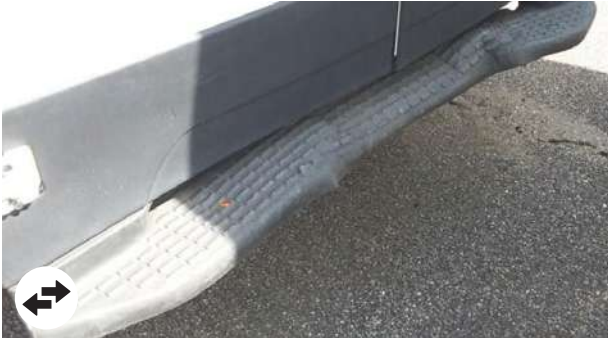
Rear footboards: Deformations not within economic repair

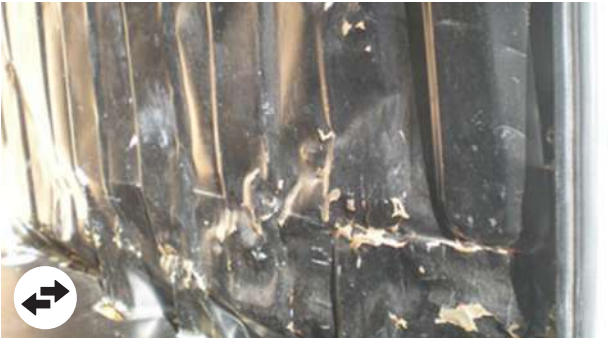
Internal deformations: Significant deformation, repair time  $> 3$  h, perforations, cuts

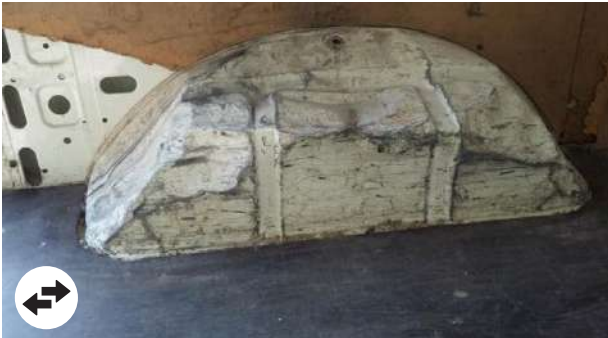
Internal deformations: Perforations, cuts, deformations beyond economic repair: Denaturing and uncorrectable deposit (powder, paint, etc.)  
(Wheel arch not recoverable if repair time  $> 3$ h)

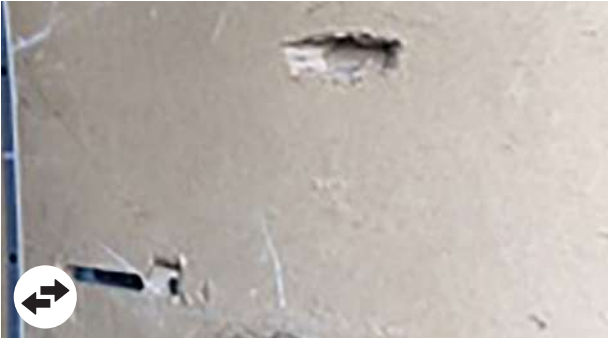
Wood internal protections: Impacts, torn panel, panel missing (excluding door upper panels)

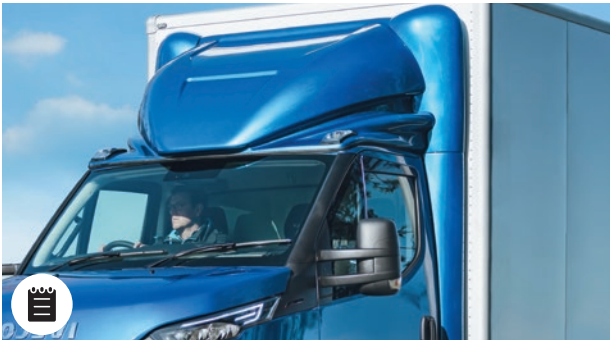
Cabover and deflector: Faint scratch in keeping with the vehicle appearance

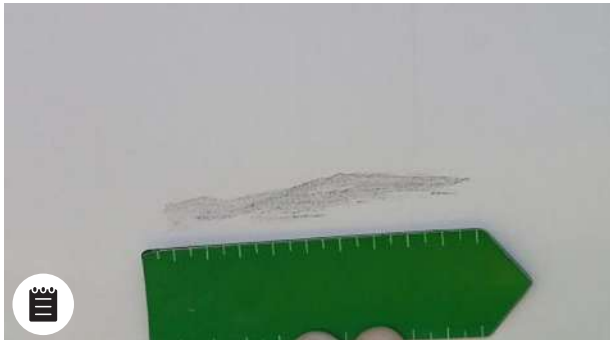
Side panels: Faint scratch with material removal ≤ 10 cm

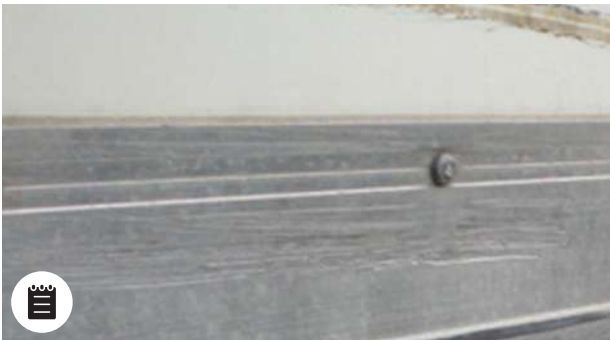
Underbody side profiles: Faint scratch

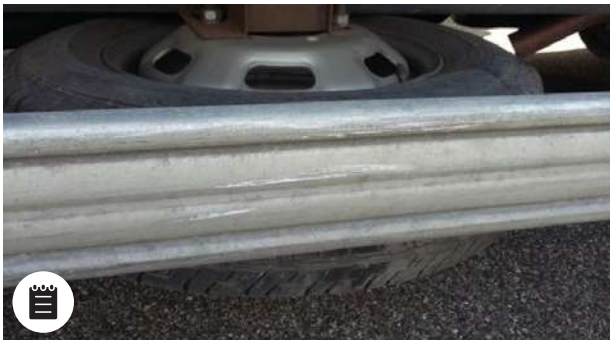
Bike racks: Faint scratch

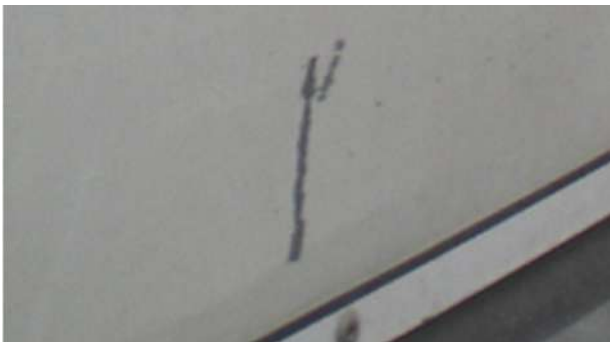
Side and rear doors: Slight deformation:  
Repair time ≤ 1 h

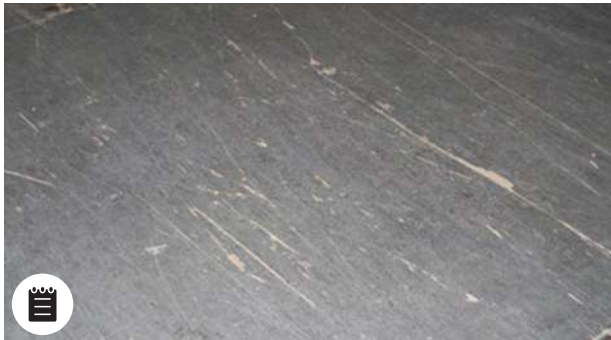
Flooring: Slight deformation, superficial wear

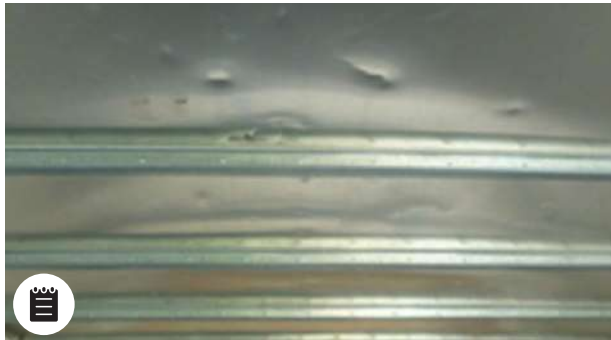
Roof space: Slight deformation in keeping with the vehicle appearance

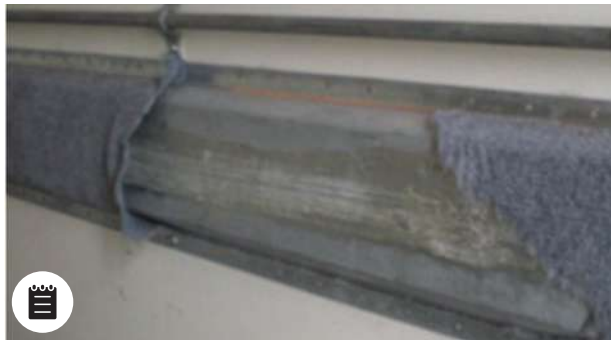
Upholstery and rods: Carpet torn or detached

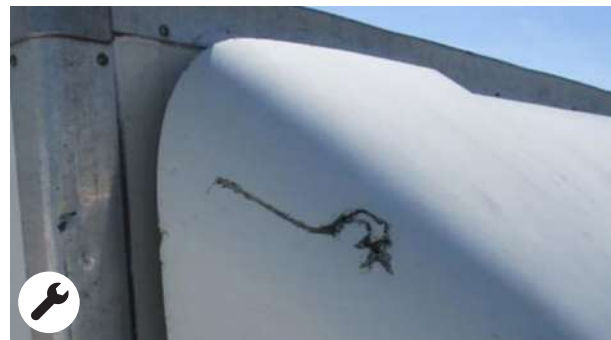
Cabover and deflector: Within economic repair

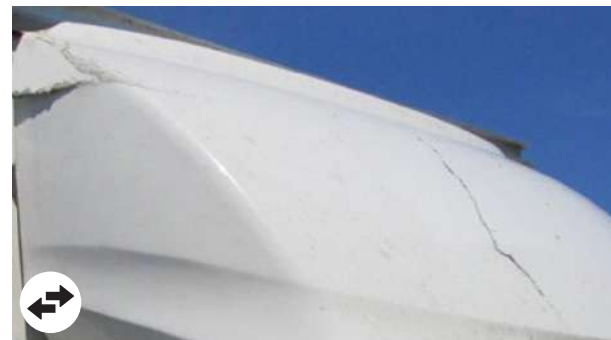
Cabover and deflector: Significant crack, missing part or beyond economic repair

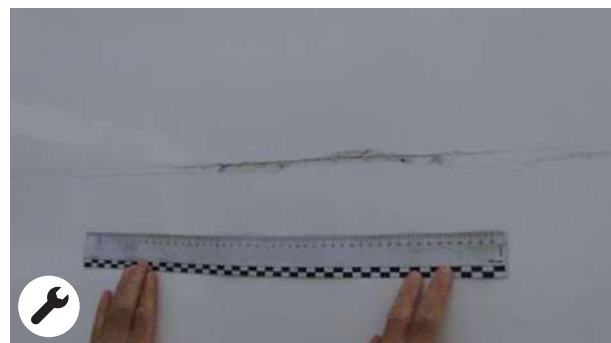
Side panels: Scratch with removal of material  $\geq 20$  cm within economic repair.  
Option to paint half panel

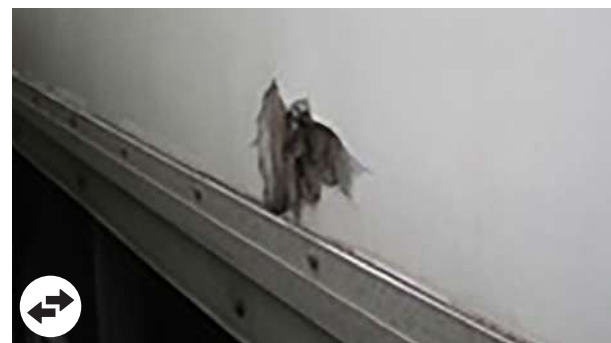
Wood side panels: Damaged wood support  $\geq 20$  cm

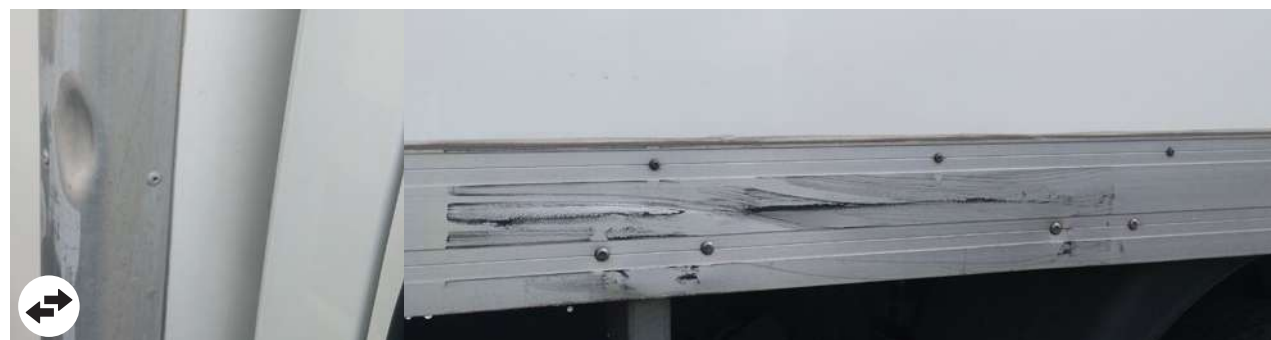
Underbody side profiles: Deformations within economic repair

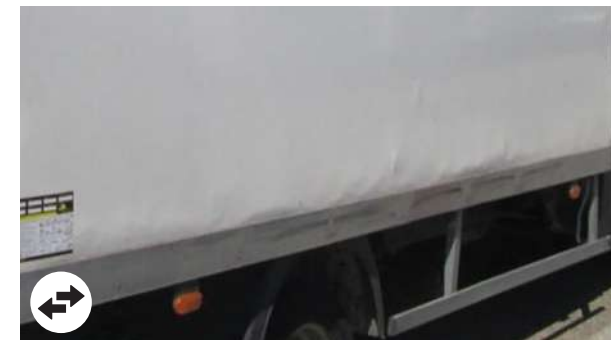
Fiberglass side panels: Deformation on lower part, length of  $> 1$  m  
NB: Replacement of the front panel of the underbody requires removal of the underbody.

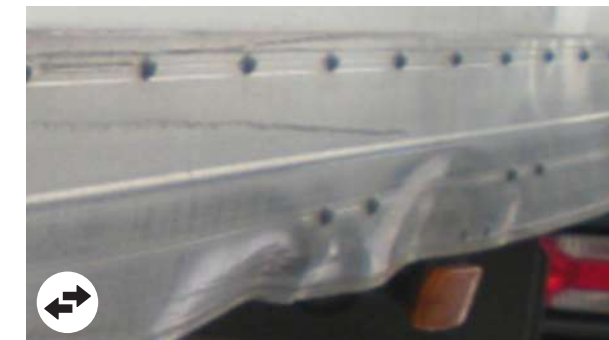
Underbody side profiles: Deformations beyond economic repair, perforations, removal of a section of the profile

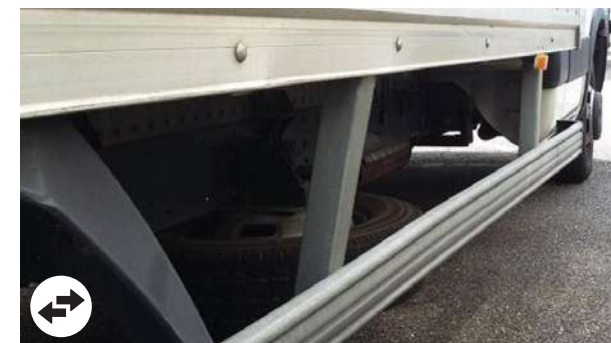
Side underun guards: Deformation within economic repair

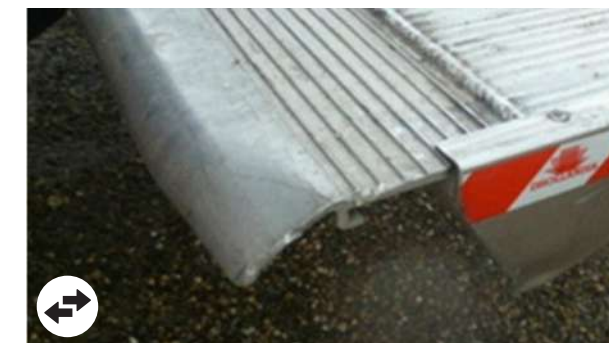
Tail lift: Deformations of platform within economic repair

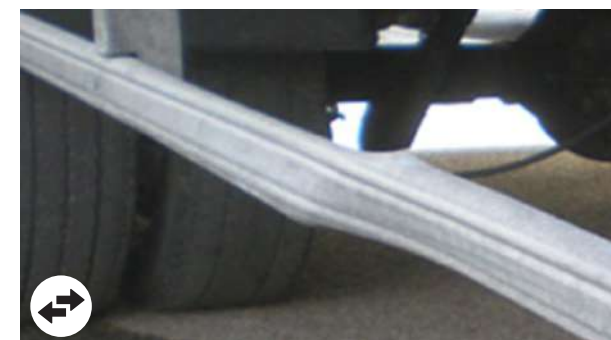
Side underun guards: Deformation beyond economic repair

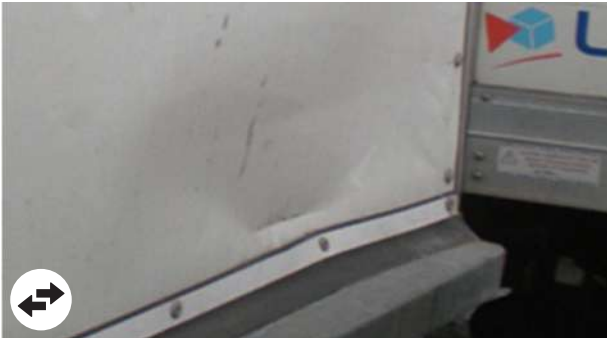
Side and rear doors: Significant deformation: Repair time > 1 h within economic repair, closure not sealed

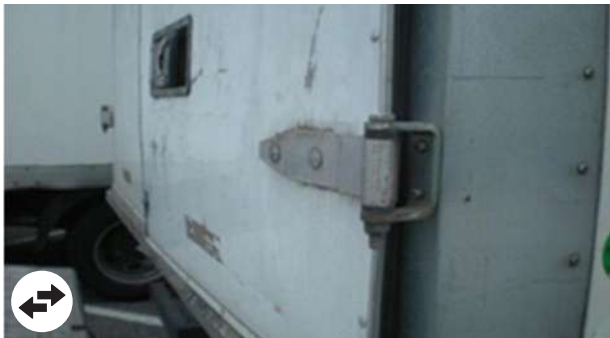
Side and rear doors: Doors bent at fastening points for hinges, broken, perforated, or beyond economic repair

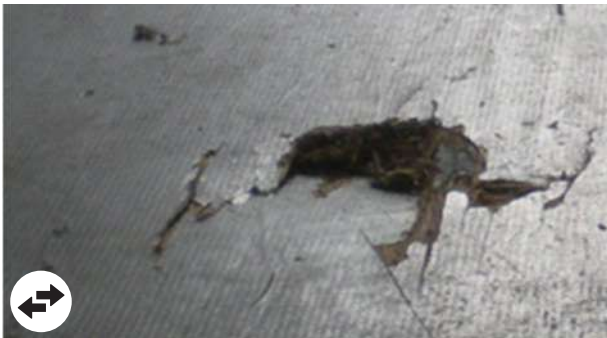
Flooring: Deformations or perforations within economic repair

Deformations or perforations beyond economic repair. Option to exchange flooring by section

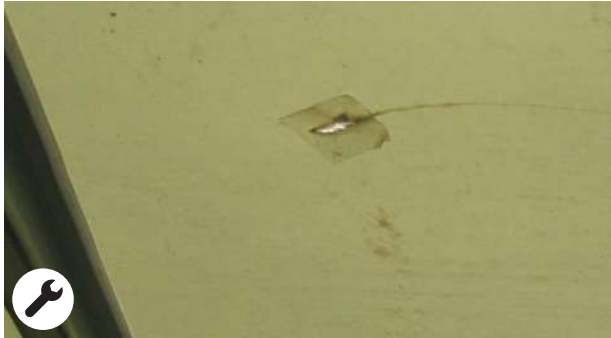
Roof space: Perforated or torn within economic repair

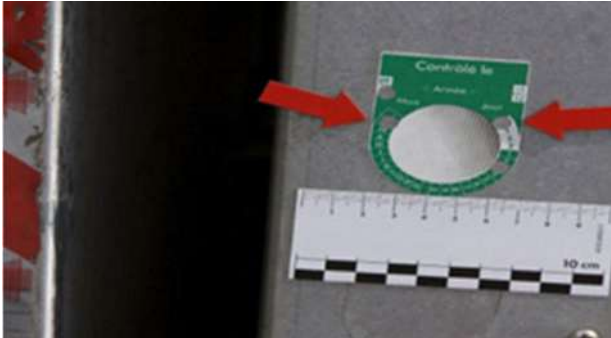
Tail lift: Expired check dates

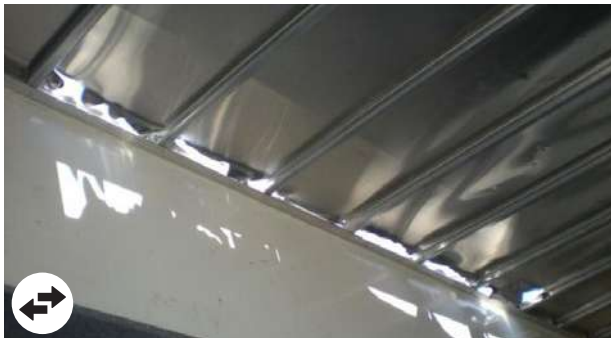
Roof space: Frame damaged, leather not within economic repair

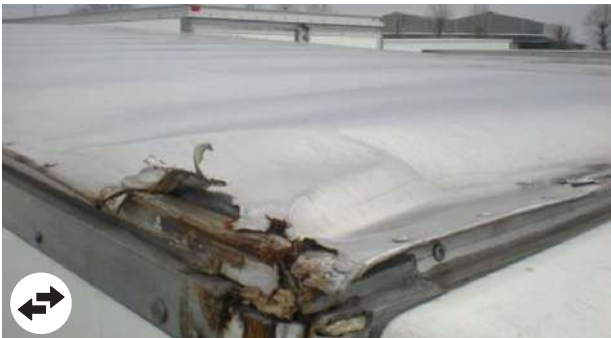
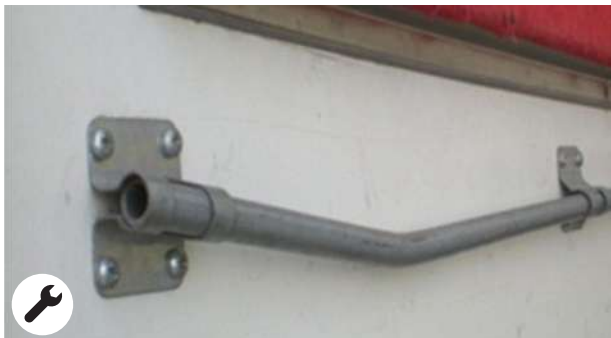
Upholstery and rods: Rods and upholstery deformed within economic repair

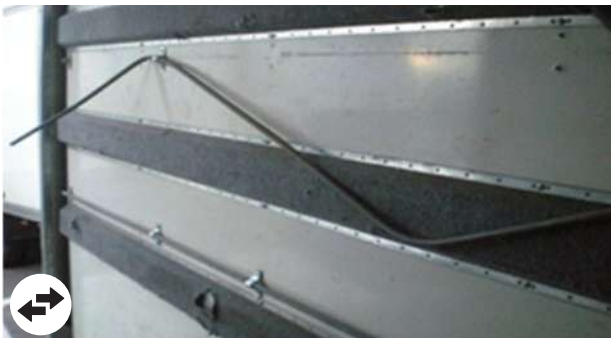
Upholstery and rods: Rods, fastenings, upholstery missing or deformed beyond economic repair

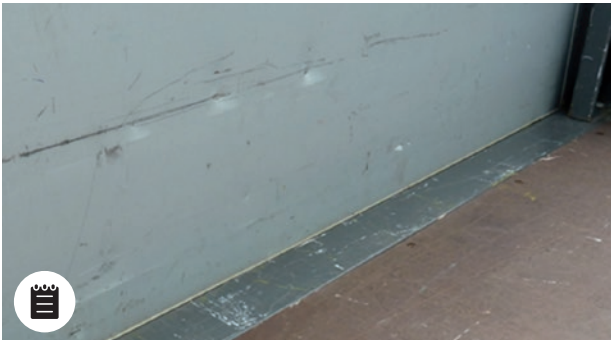
Faint scratches, Dropside/ Tipper Bodies deformations with a repair time  $\leq$  1 h

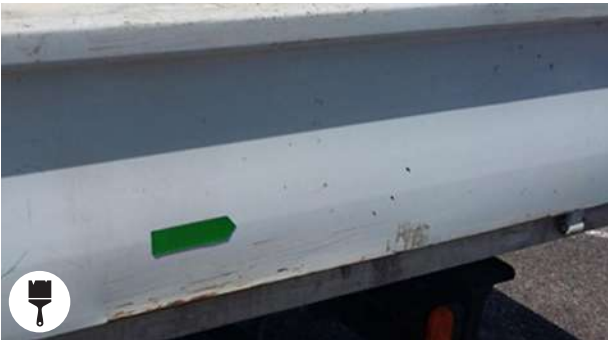
Scratches > 20 cm

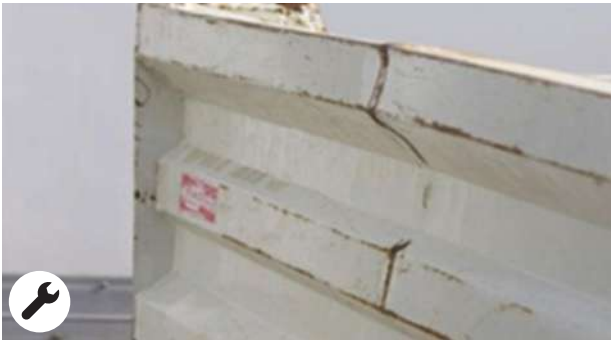
Deformations in the body closures with a repair time > 1 h within economic repair

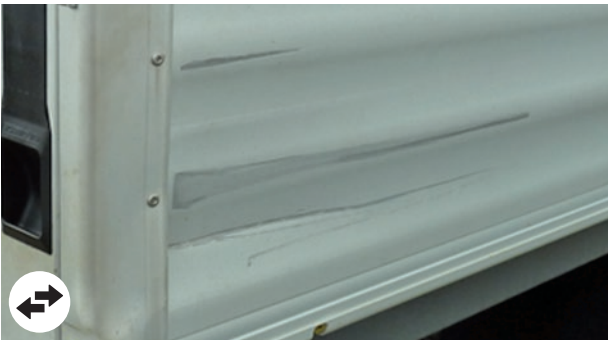
Deformations in the body closures not beyond economic repair, closure not possible or not sand-proof

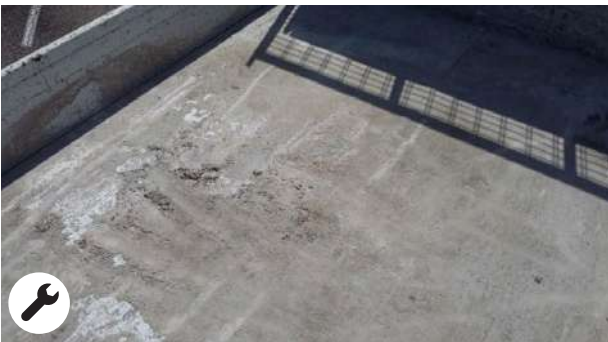
Trace of concrete or chemical product covering  $\geq$  1/4 of the surface of the bed

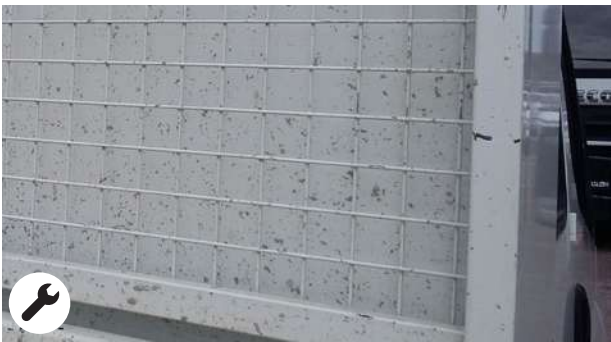
Trace of concrete or chemical product on the back of the cab

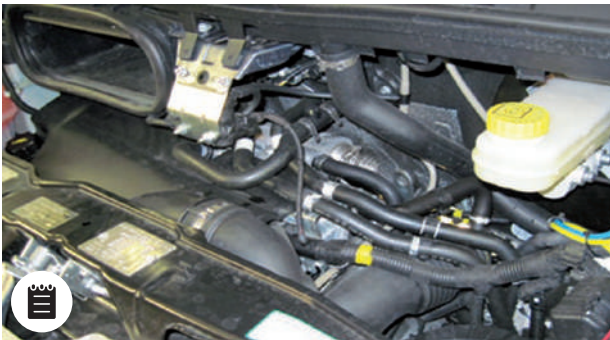
Signs of wear that do not impair road safety

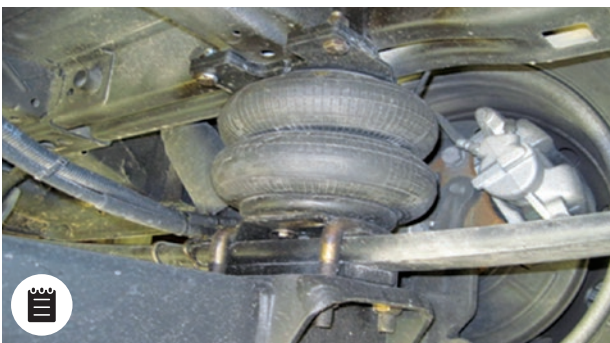
Light traces of oil (no dripping)

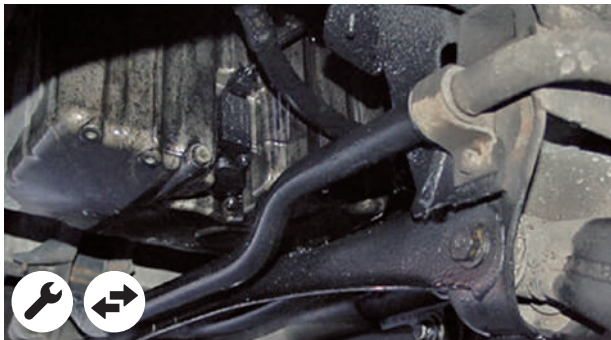
All Leaks from the engine, gearbox and differential, hydraulic suspension and dampers

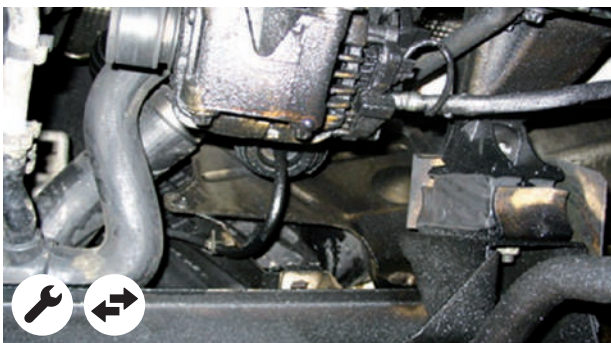
Leaks from the steering gear and power steering pump

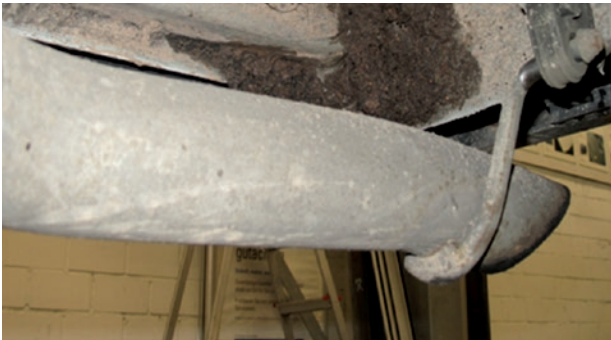
Condition conforms to technical inspection

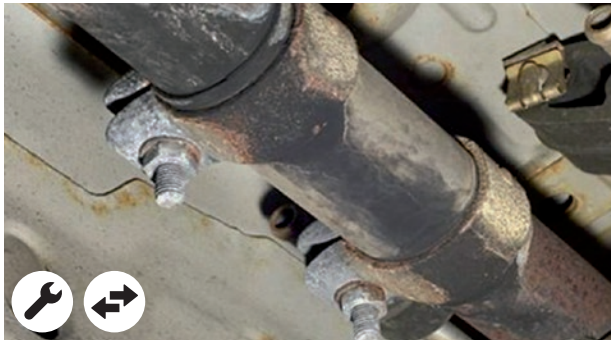
Presence of leaks

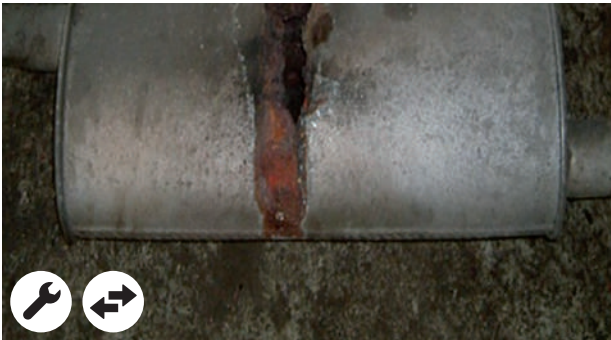
Rust

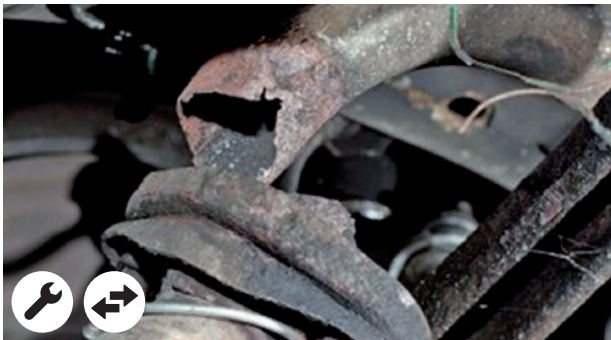
Damage due to external shocks

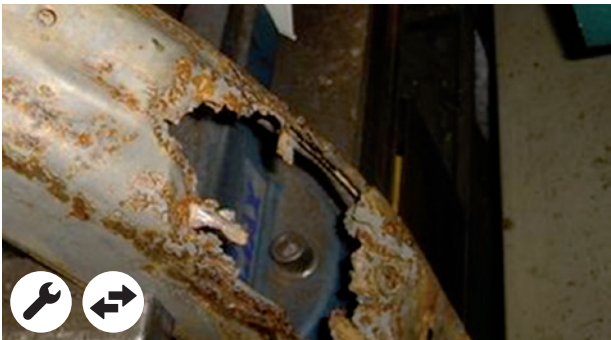
Missing equipment, e.g. exhaust outlets torn or deformed
