**IVECO**  
CERTIFIED PRE-OWNED

# Vehicle Return Guidelines

This damage catalogue aims to prepare you for returning your IVECO vehicle when your usage period comes to an end.

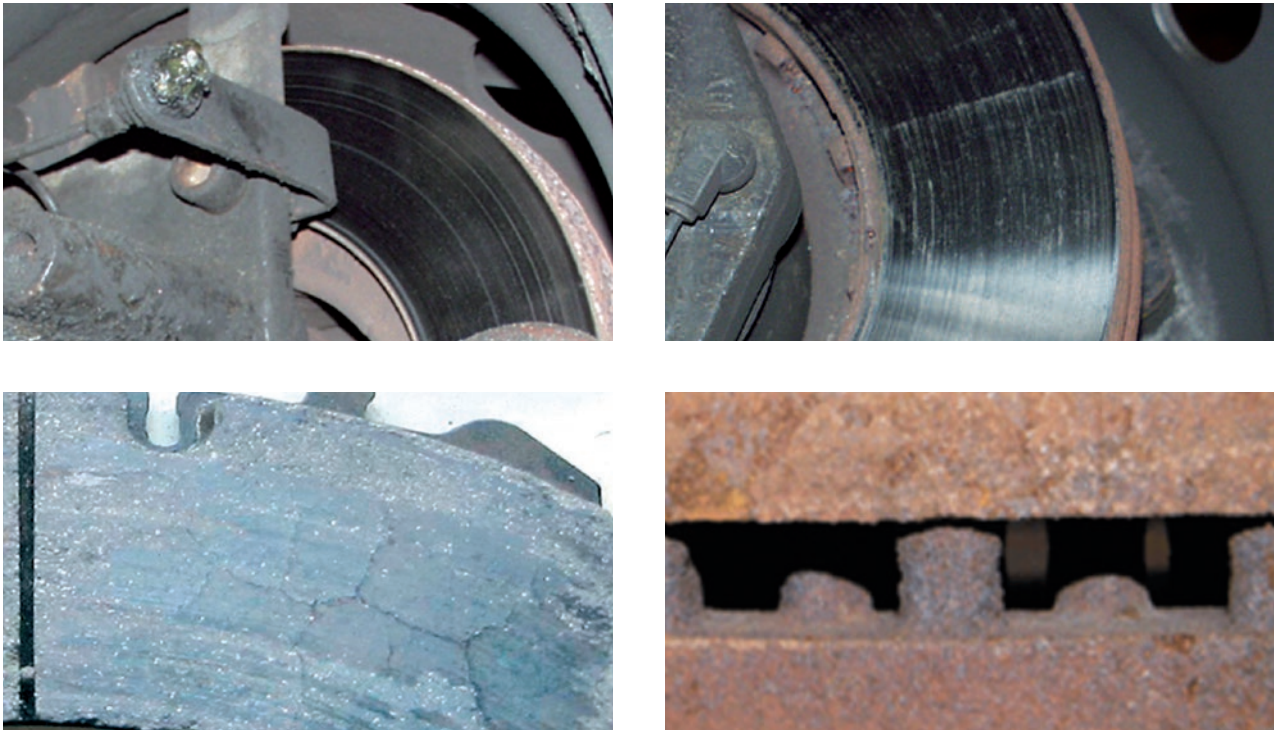
Normal condition and in accordance with the age and mileage of the vehicle

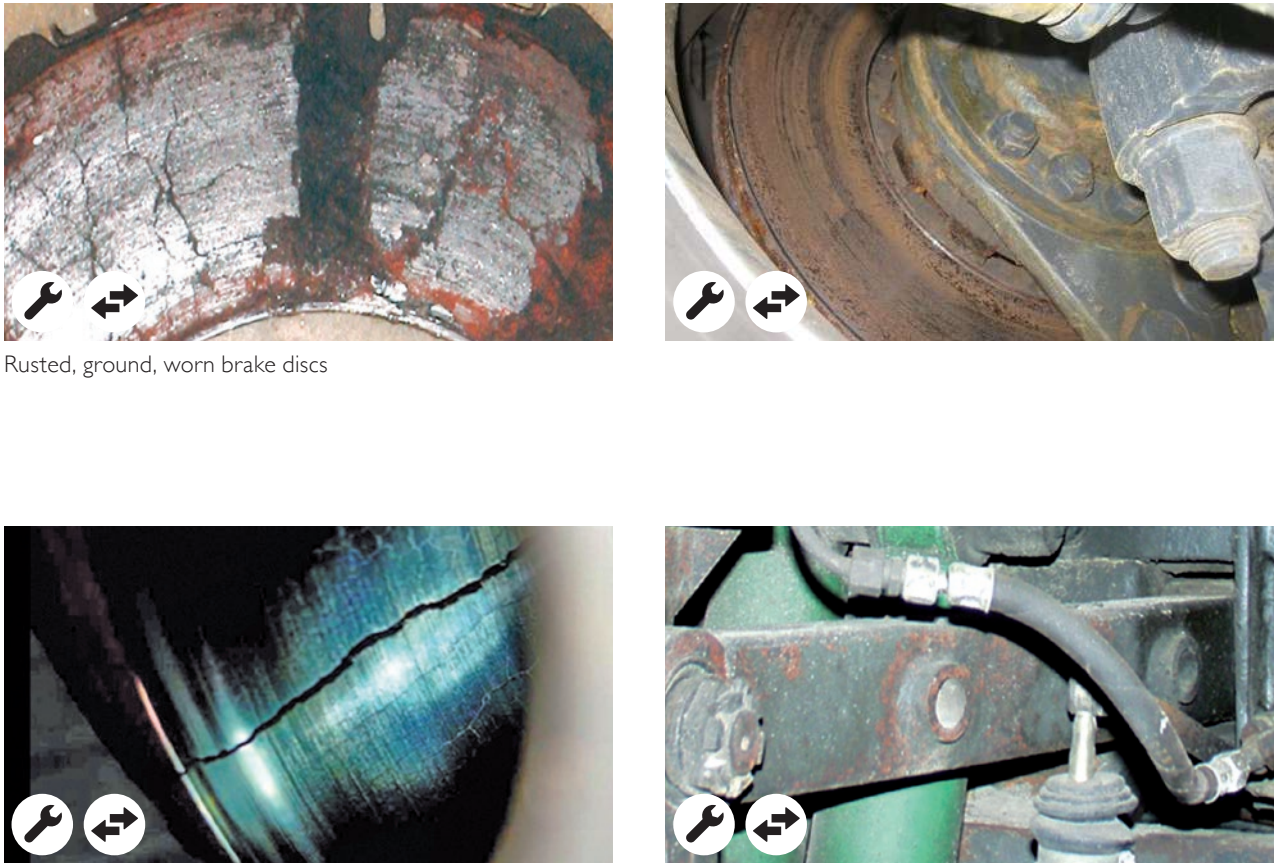
Rusted, ground, worn brake discs

Does not conform to highway code and not valid during technical check

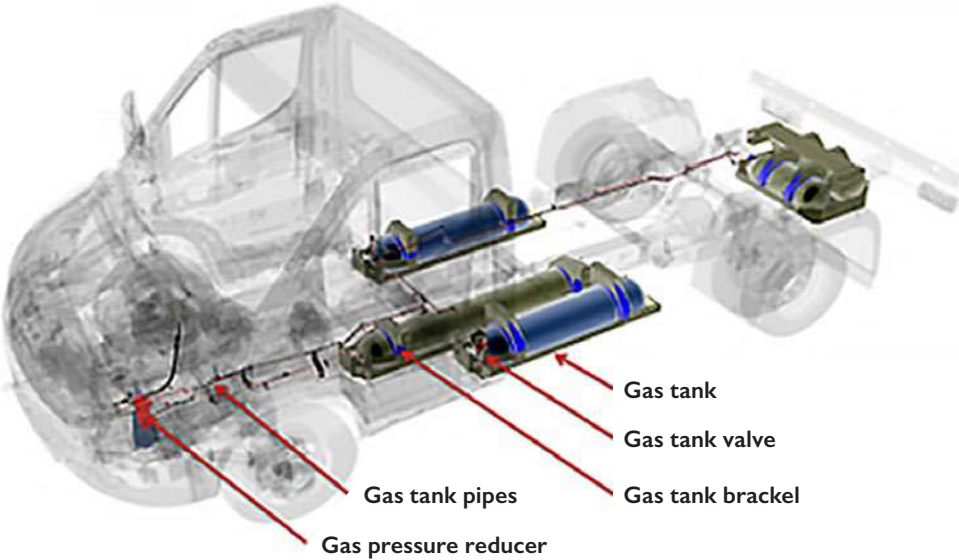
The protective covers on the CNG cylinders must be removed by the customer to allow the vehicle return inspection report to be carried out. The customer must refit them before the vehicle is taken to the storage facility.

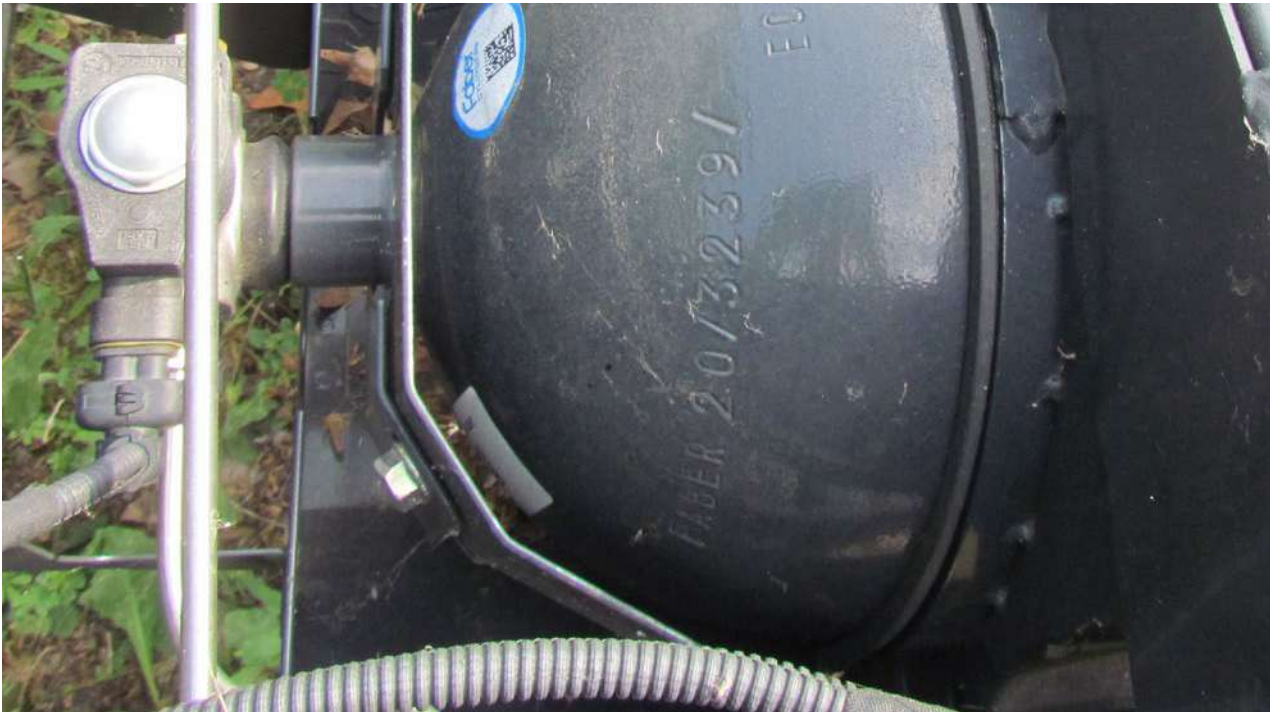
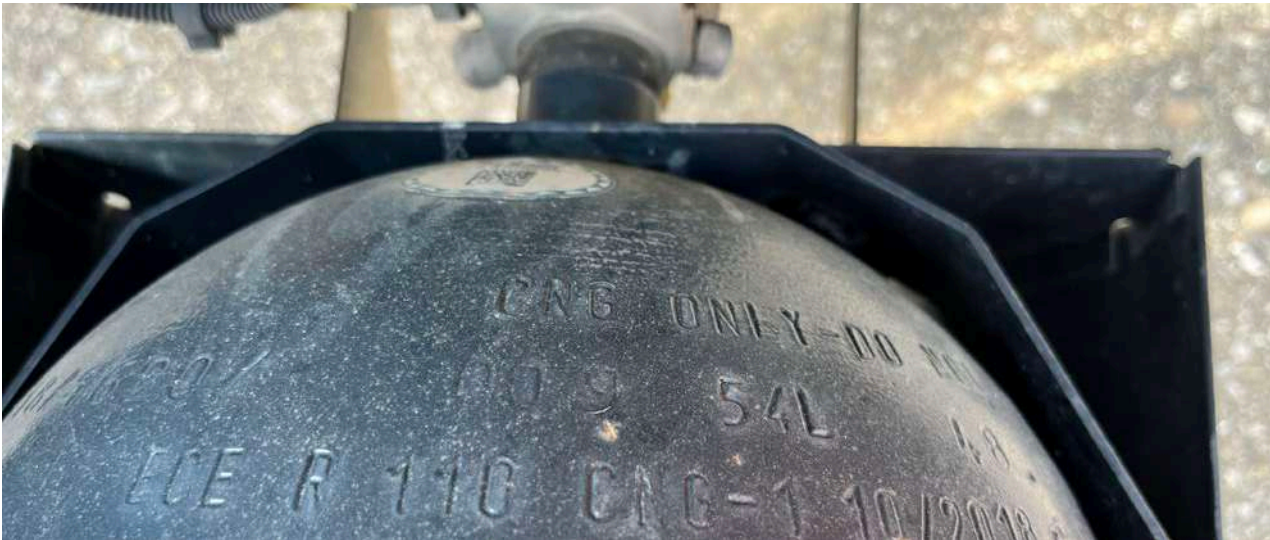
# Administrative and markings

Presence of an up-to-date validity certificate legible for CNG cylinder.

Notes: According to, each cylinder shall be visually inspected at least every **UN/ECE-R110 regulation 48 months** after the date of its entry into service on the vehicle (vehicle registration), and at the time of any reinstallation, for external damage and deterioration.

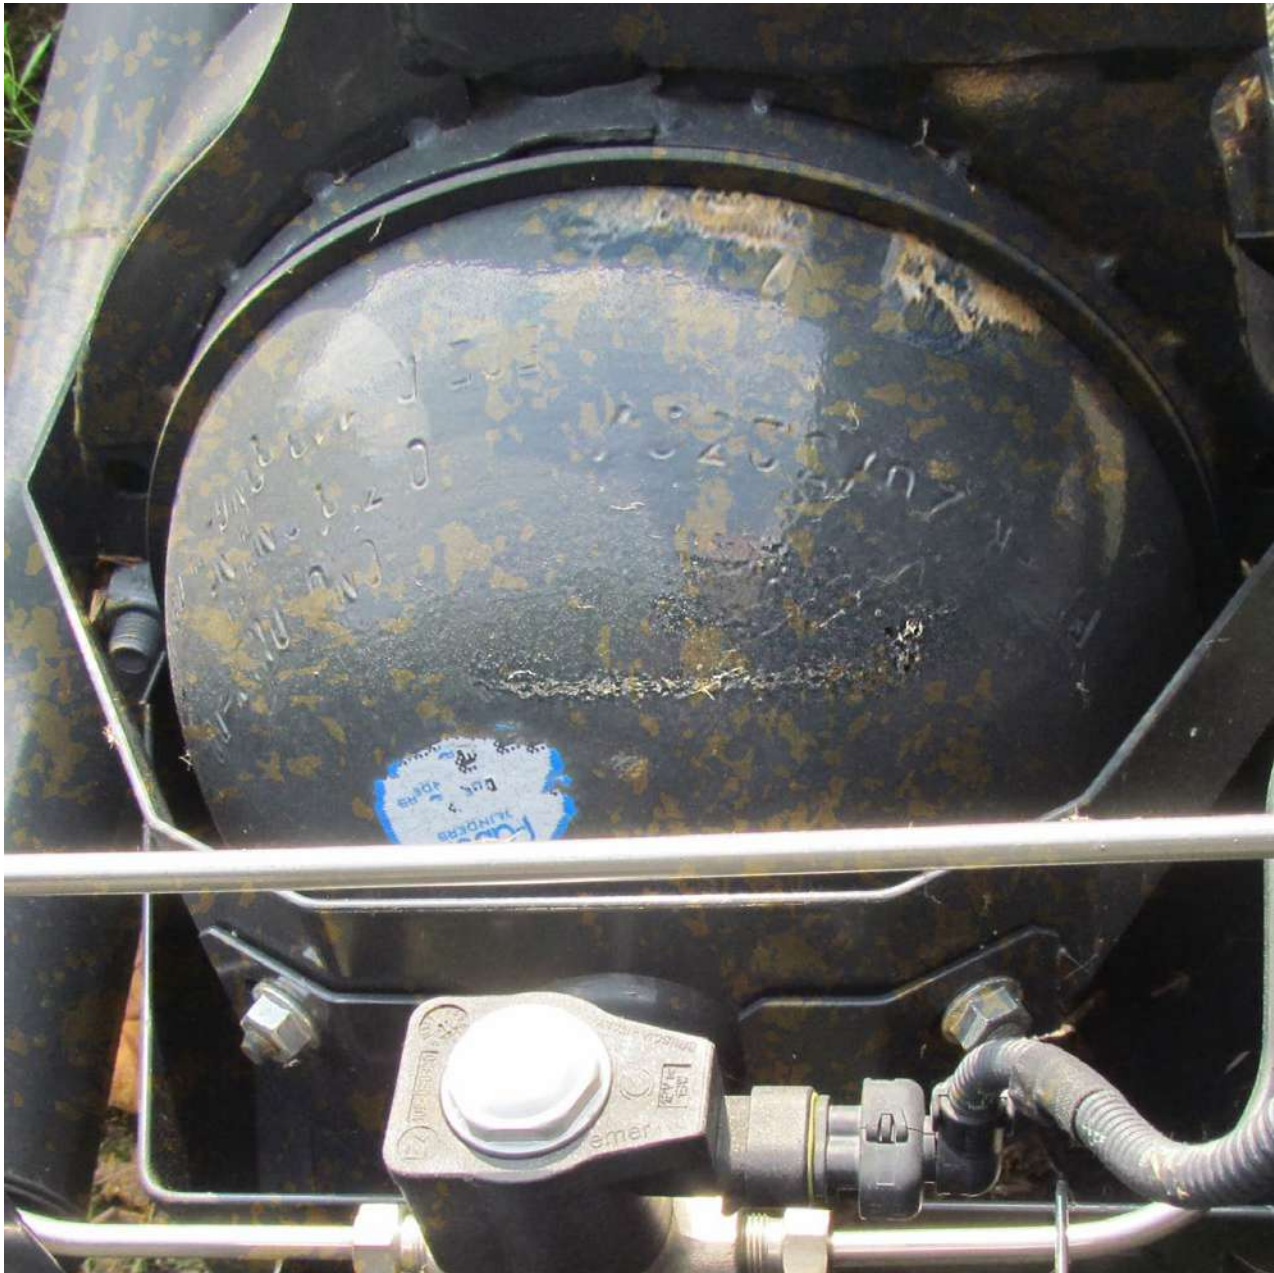
Original CNG cylinder identification markings absent or illegible

- charge for replacement of CNG tank with a new one

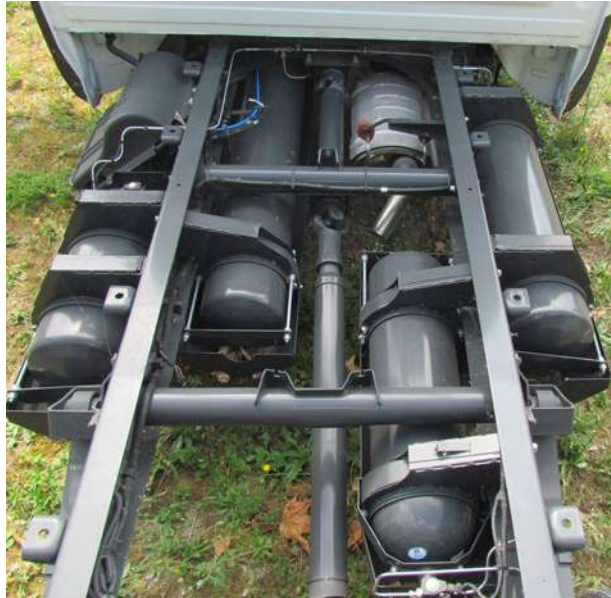
# CNG tank

CNG tank must be returned in proper conditions as illustrated in pictures.

Notes: According to regulation UN ECE R110 each cylinder shall be visually inspected at least every 48 months after the date of its entry into service on the vehicle (vehicle registration), and at the time of any reinstallation, for external damage and deterioration

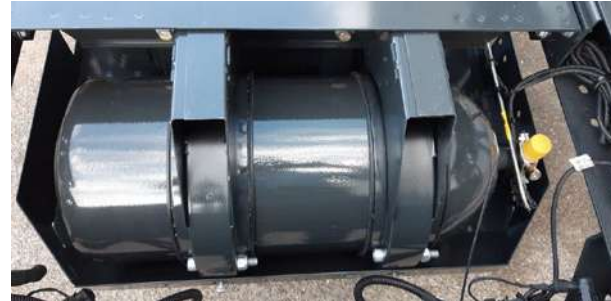
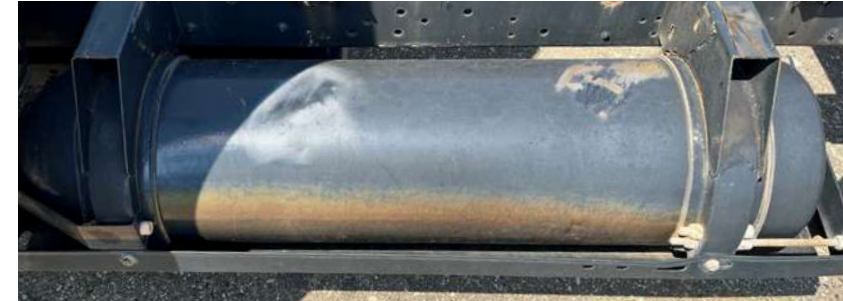
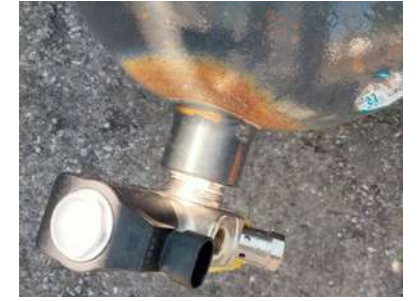
- Evidence of **tank repairs** → charge for tank replacement.
- **Tank holed** → charge for tank replacement.
- **Dent in outer shell:**
- Maximum depth of deformation  $\leq 7 \text{ mm}$  with no signs of frost or sweating → note without charge for damage (note in the expert report).

- Depth of deformation  $> 7 \text{ mm}$  → charge for tank replacement.
- Dents on the rear head or on the protective shroud → charge for tank replacement.

- **Surfaces scratches** in outer shell → note without charge for damage.
- Any visual **ice or frost spot** on the outer shell or heads (excluding knuckle and its mounted plumbing) → charge for tank replacement.

- Dents, cracks, splits or visible **leaks at the weld seams or on welded components** → charge for tank replacement.
- Any cracks, splits or visible **leaks on the outer shell, rear head or protective shroud** → charge for tank replacement.

- **Damage to the fill receptacle or VENT valve** → charge for replacement of components.
- Inspect the **pump-out port or cap for signs of damage** or tampering. **Half round cap** must be intact and secured to the tank. If not present → charge for tank replacement.

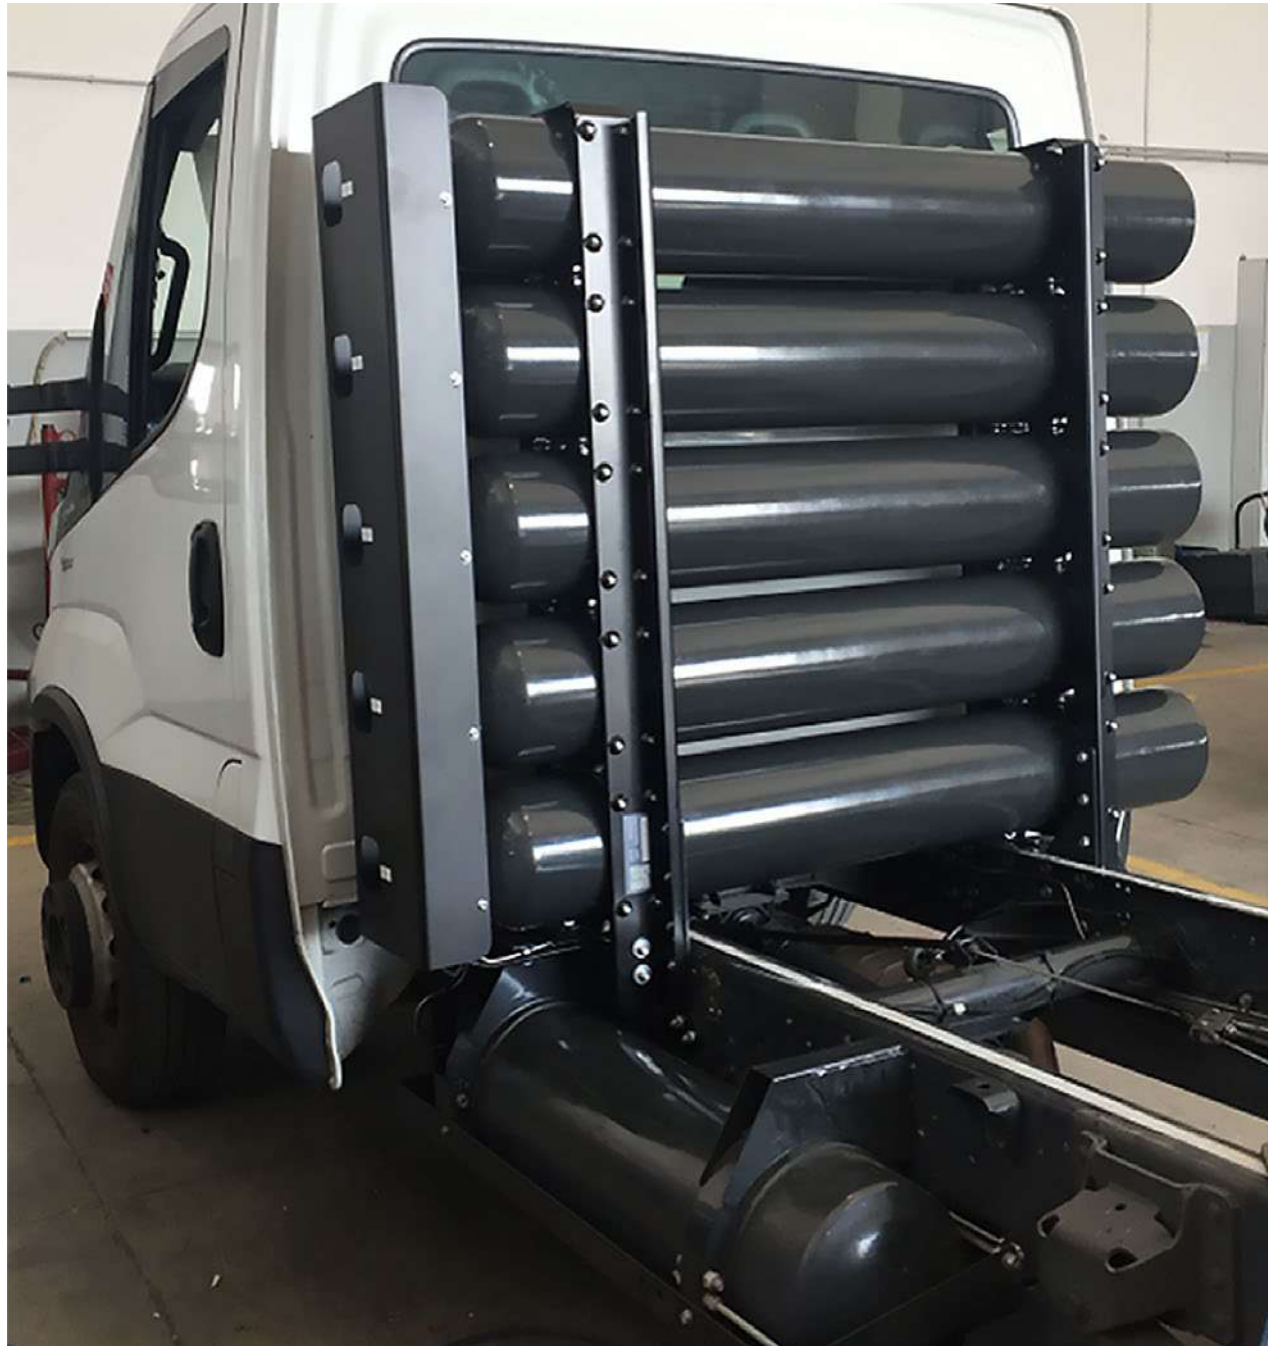
## CNG cylinders

CNG cylinders must be returned in proper conditions as illustrated in pictures.

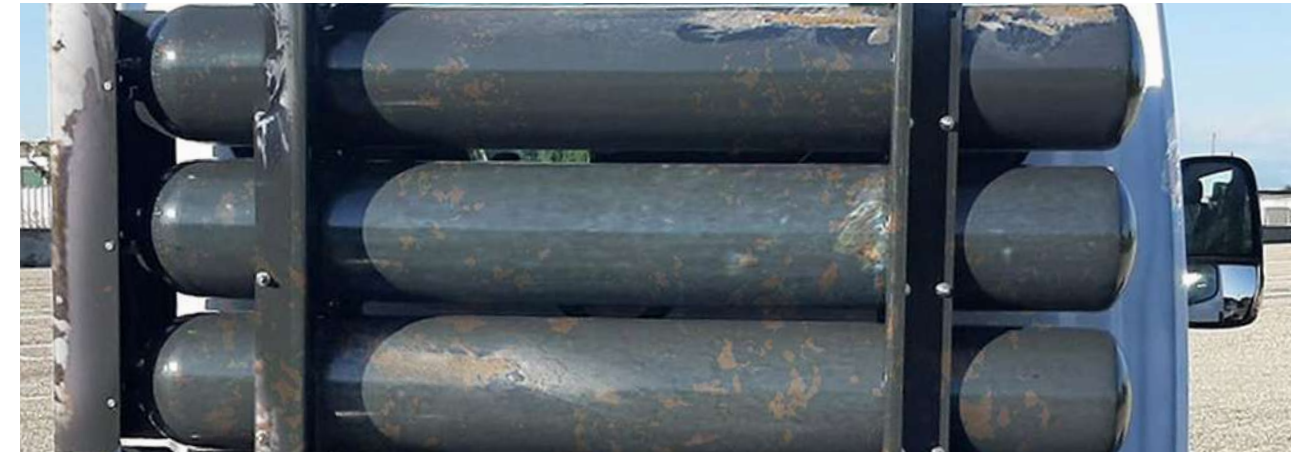
Evidence of repairs to the CNG cylinder → charge for replacement for CNG cylinder.

- Holes in the CNG cylinder → charge for replacement for CNG cylinder.
- Dents on the CNG cylinder:

If no metal is detached and the maximum depth of the deformation is  $\leq 1.6$  mm and  $\leq 50$  mm in diameter/length → note without charge for damage.

Detachment of metal or maximum depth of deformation  $> 1.6$  mm and  $> 50$  mm in diameter/length → charge for replacement of CNG cylinder.

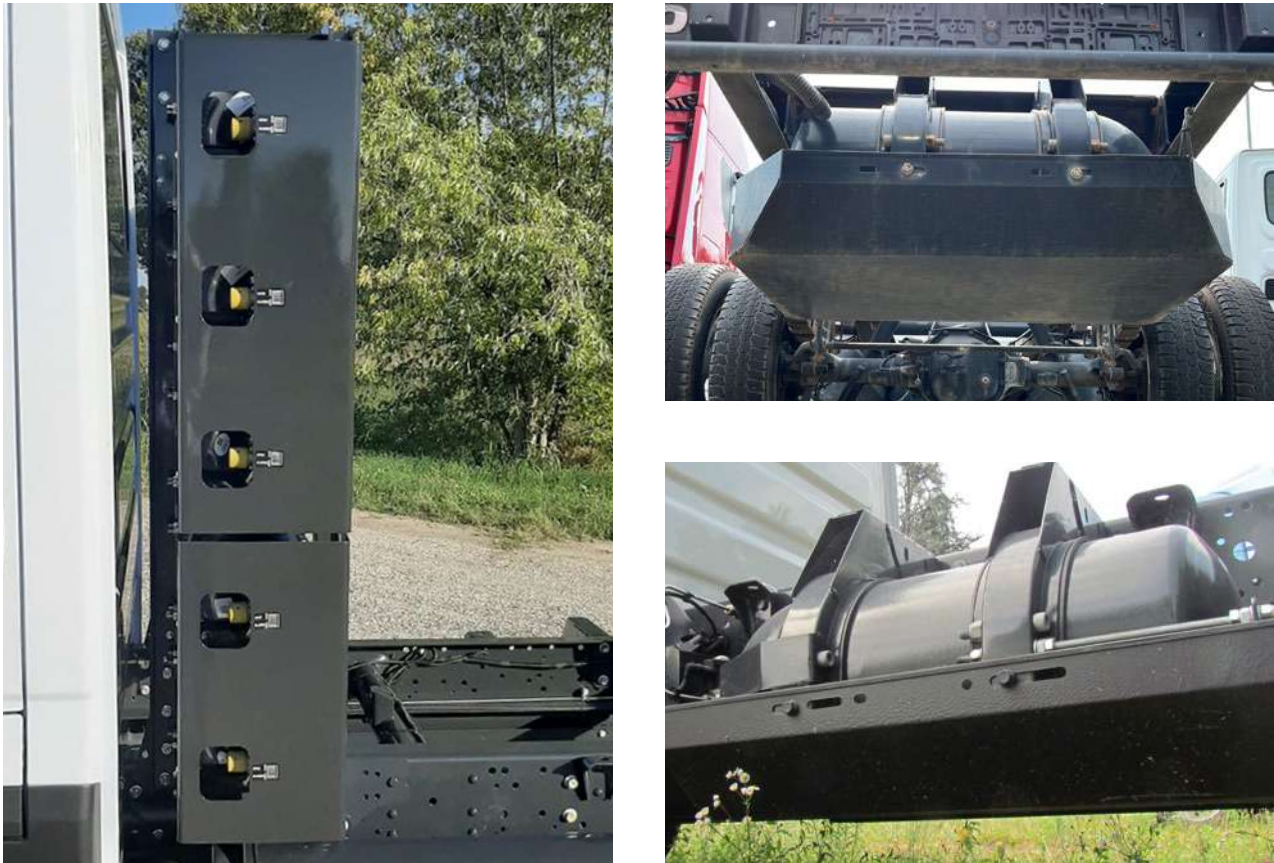
# CNG tank and cylinders protective cover

CNG cylinders protective covers must be returned in proper conditions as illustrated in pictures.

Dents, deformations, rust and/or gouges that do not affect functionality and safety are accepted.

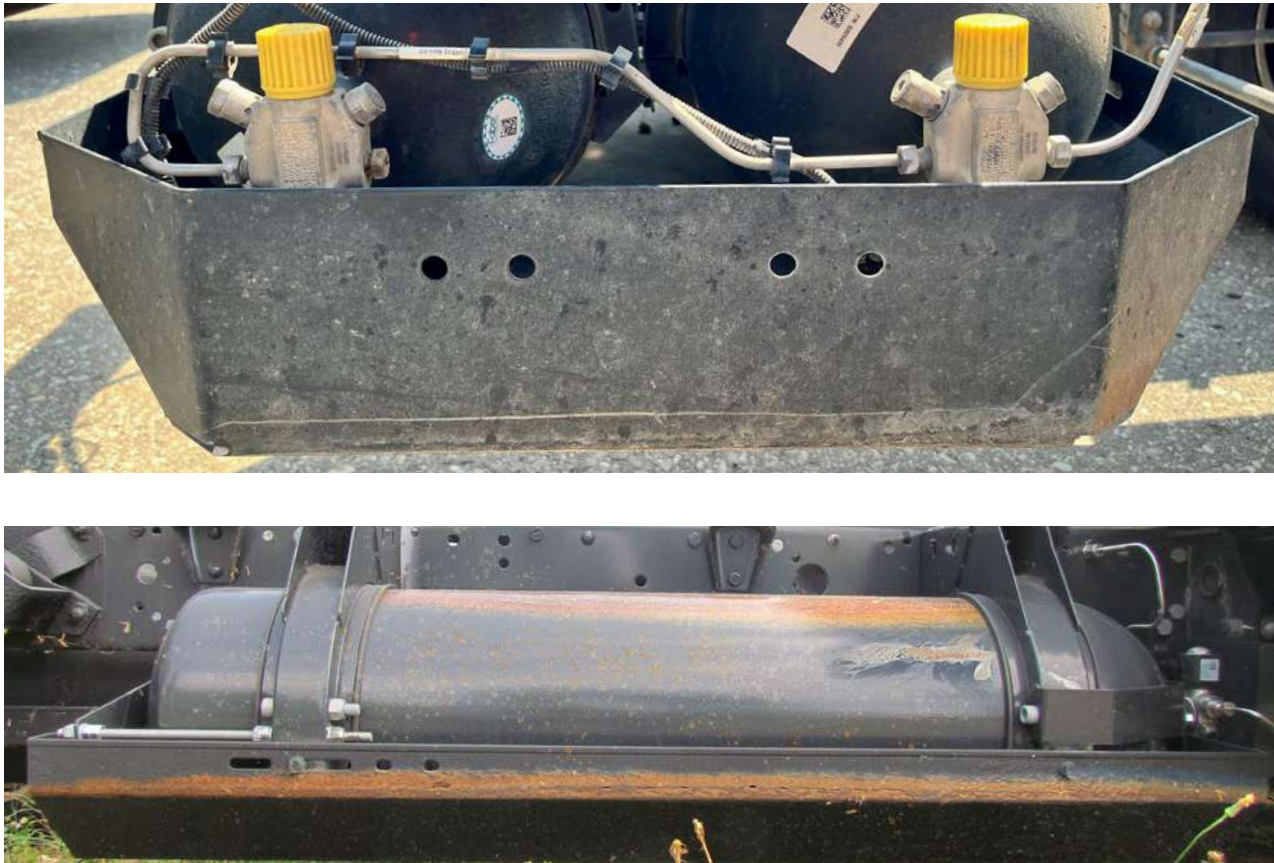
Visible dents and deformations that affect the functionality and/or safety

- charge for replacement of protective covers.

Rust, breakages and/or gouges that affect the functionality and/or safety

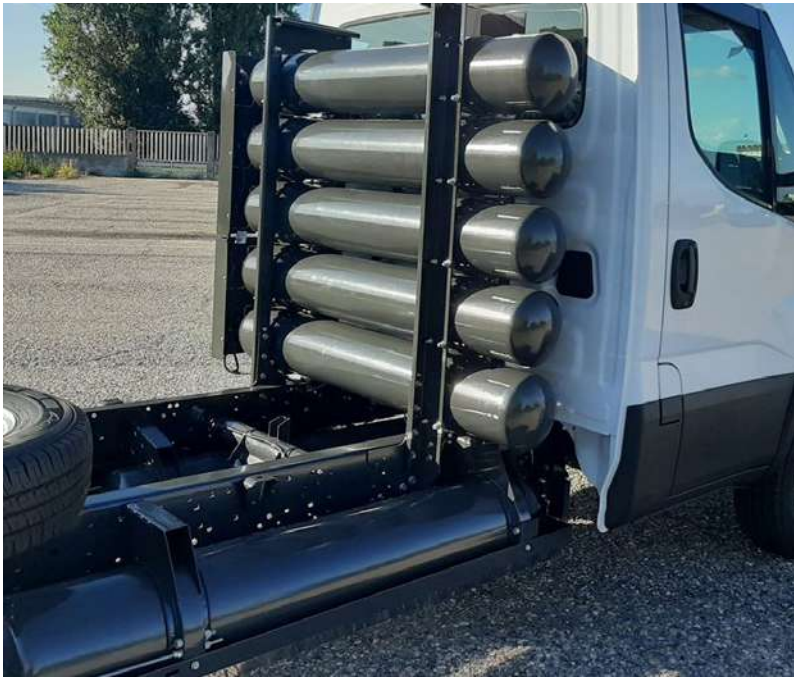
# Retainer brackets and bands for CNG cylinders and tanks

CNG cylinders must be returned in proper conditions as illustrated in picture.

Rubber must be followed the edge of the brackets.

Check that the brackets are present and properly tighten (see following pages).

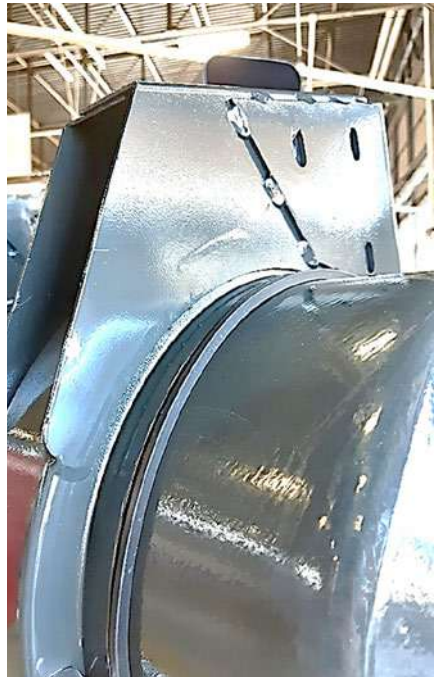
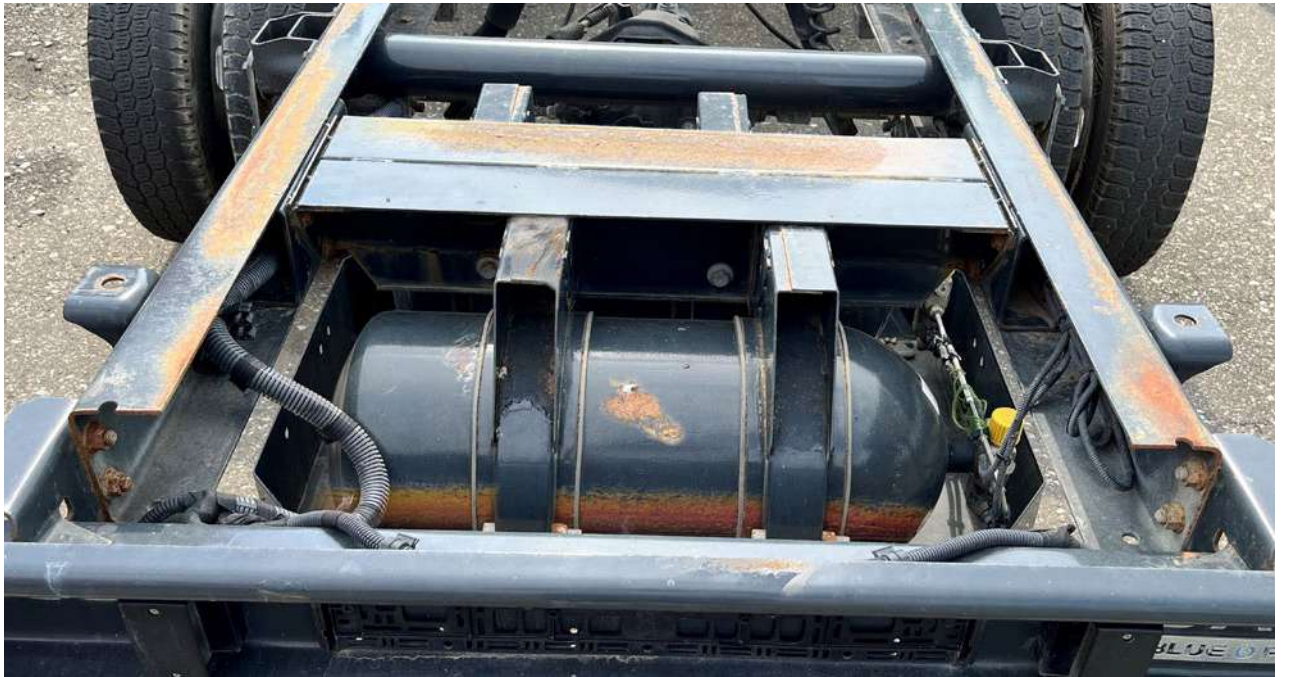
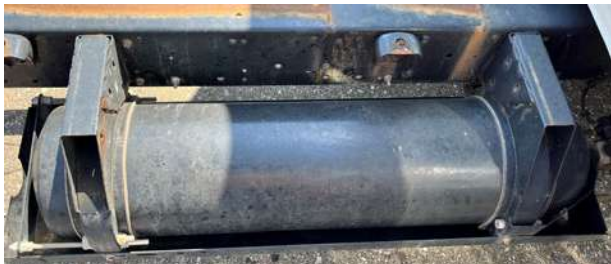
Rust, dents, breakages and/or gouges

- charge for replacement of brackets and bands.

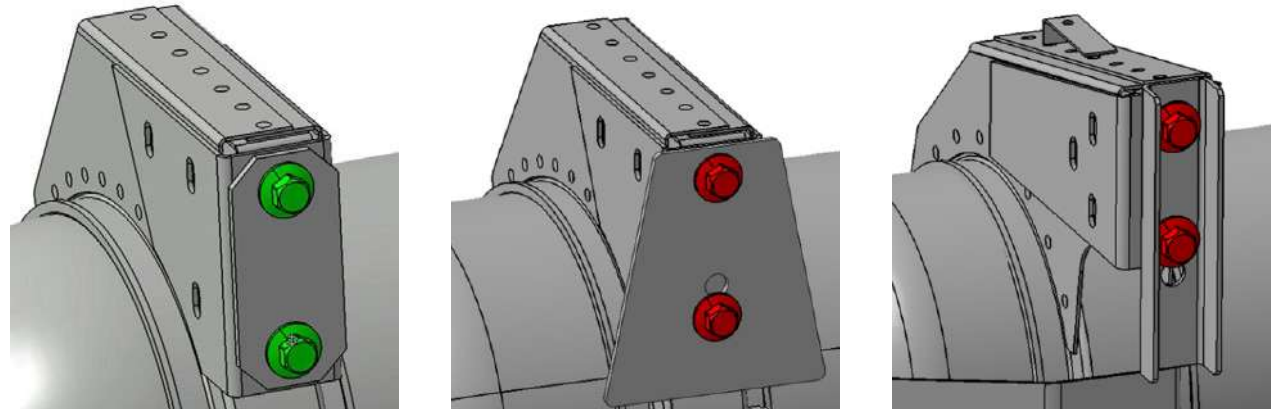
Tank support brackets to chassis and rear cross member fastening with stiffening plates

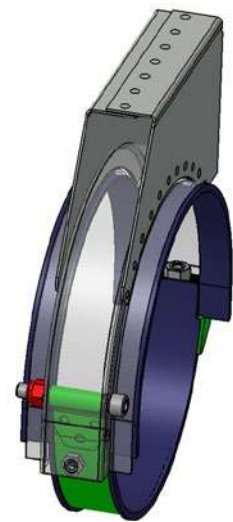
Band to tank bracket fastening: check the status of components (oxidation, fatigue, etc.)

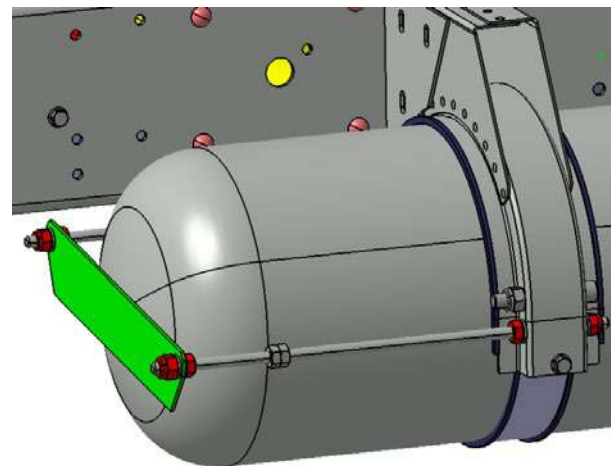
Tank tie-rod fastening: it maintain the tank in case of crash. Check the status of components.

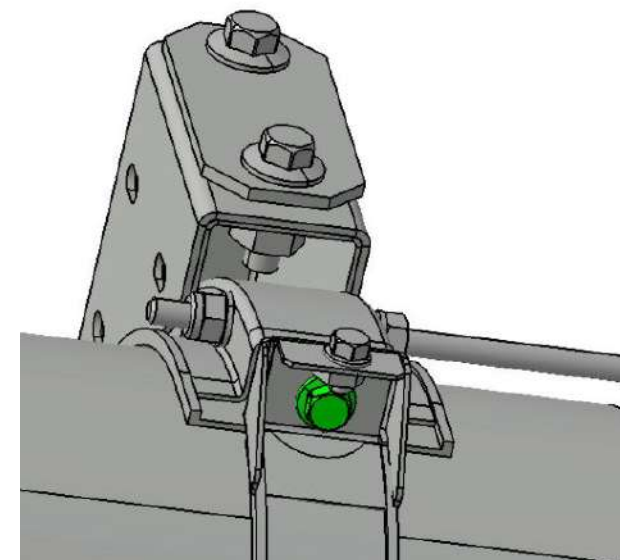
Tank support band fastening. The support is also checked in case of vehicle inspection (Italy Market: each 4 years)

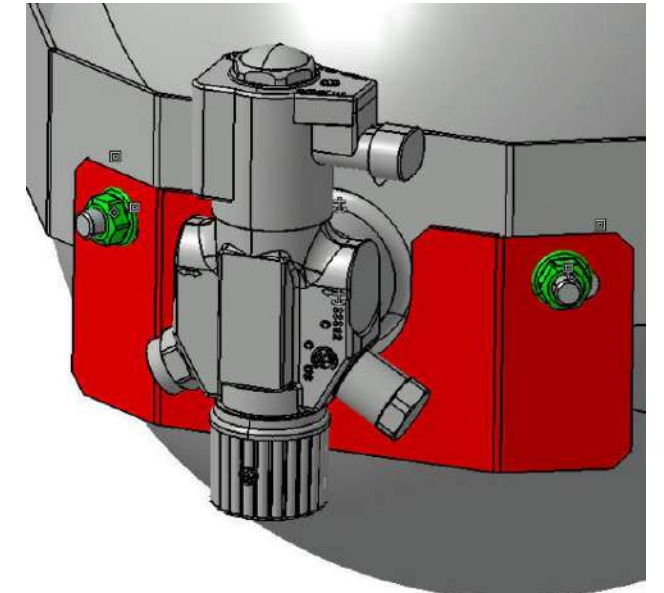
Firewall bracket fastening. The support is also checked in case of vehicle inspection (Italy Market: each 4 years)

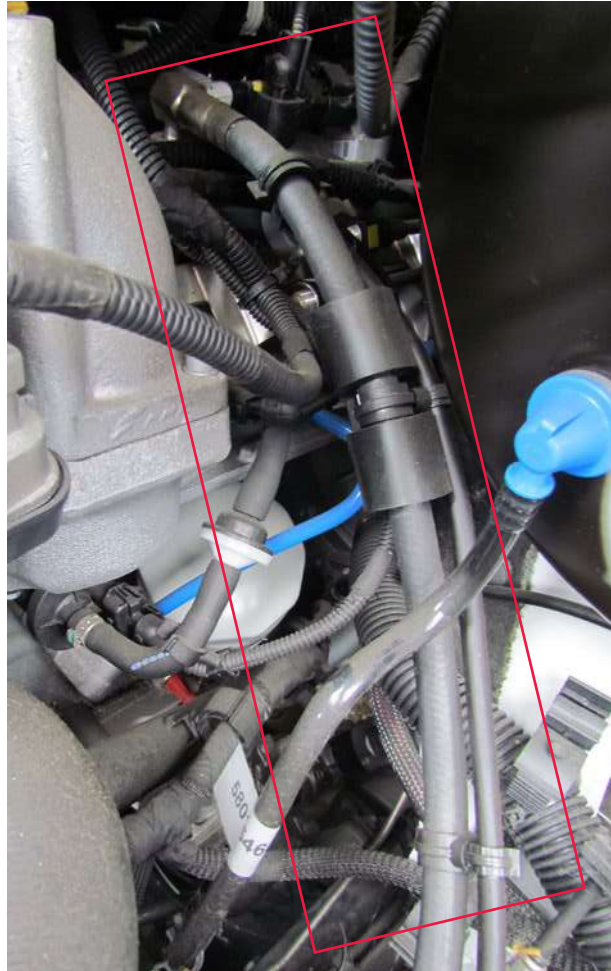
## Medium pressure pipe

Medium pressure pipe must be returned in proper conditions as illustrated in picture.

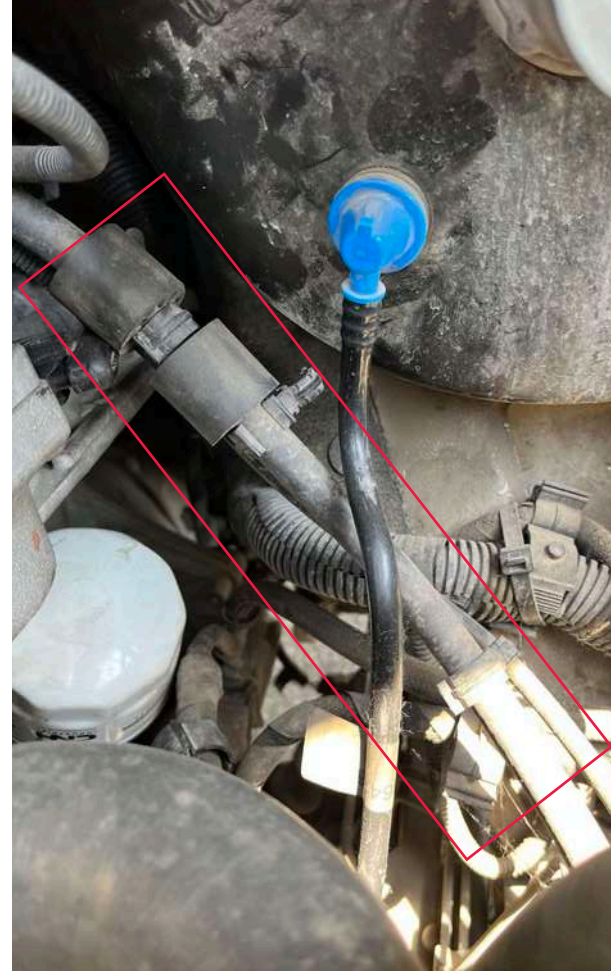
Cuts/scratches/gouges/abrasions

- charge for replacement of medium pressure pipe.

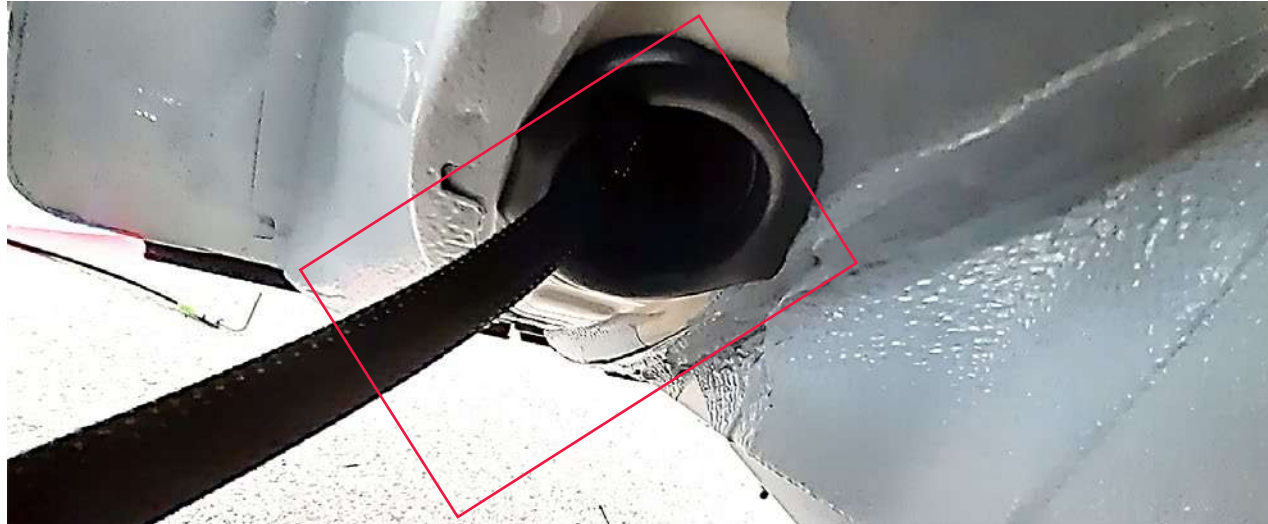
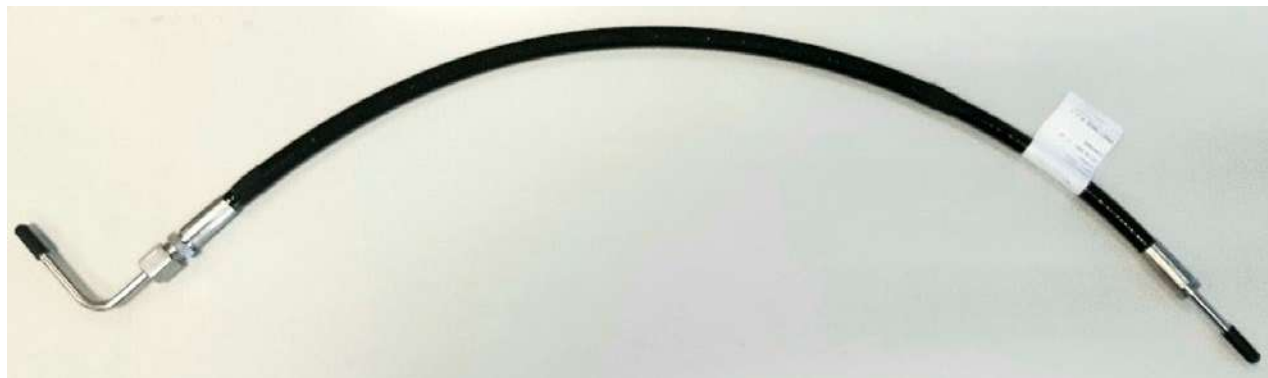
# High pressure pipe

High pressure pipe: it must be returned in proper conditions as illustrated in pictures.

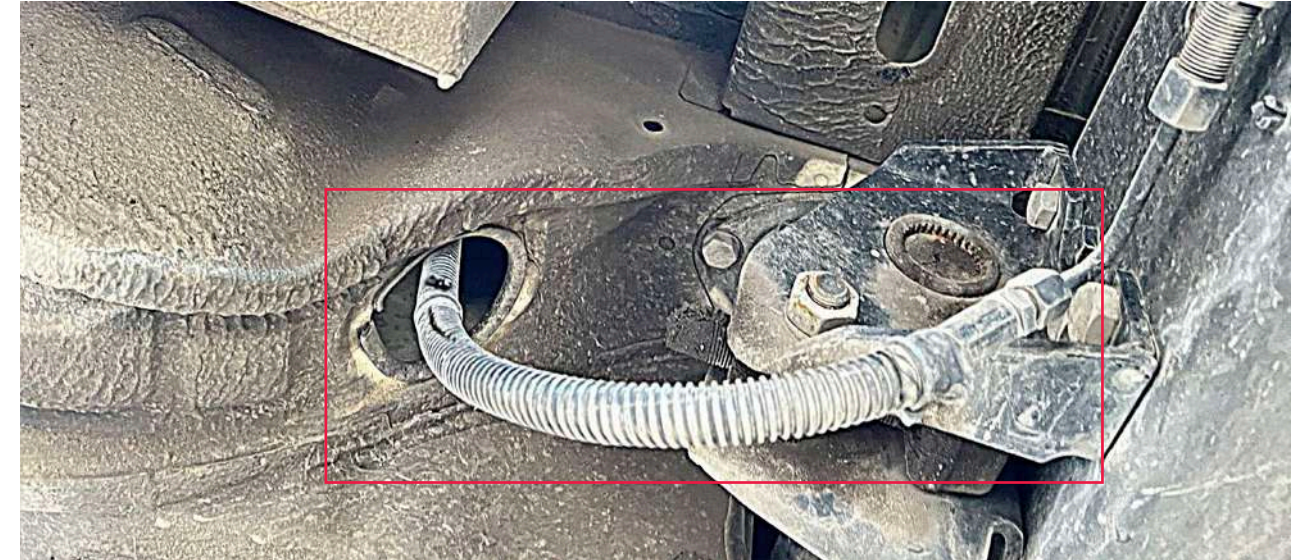
Cuts/scratches/gouges/abrasions

- charge for replacement of high pressure pipe.

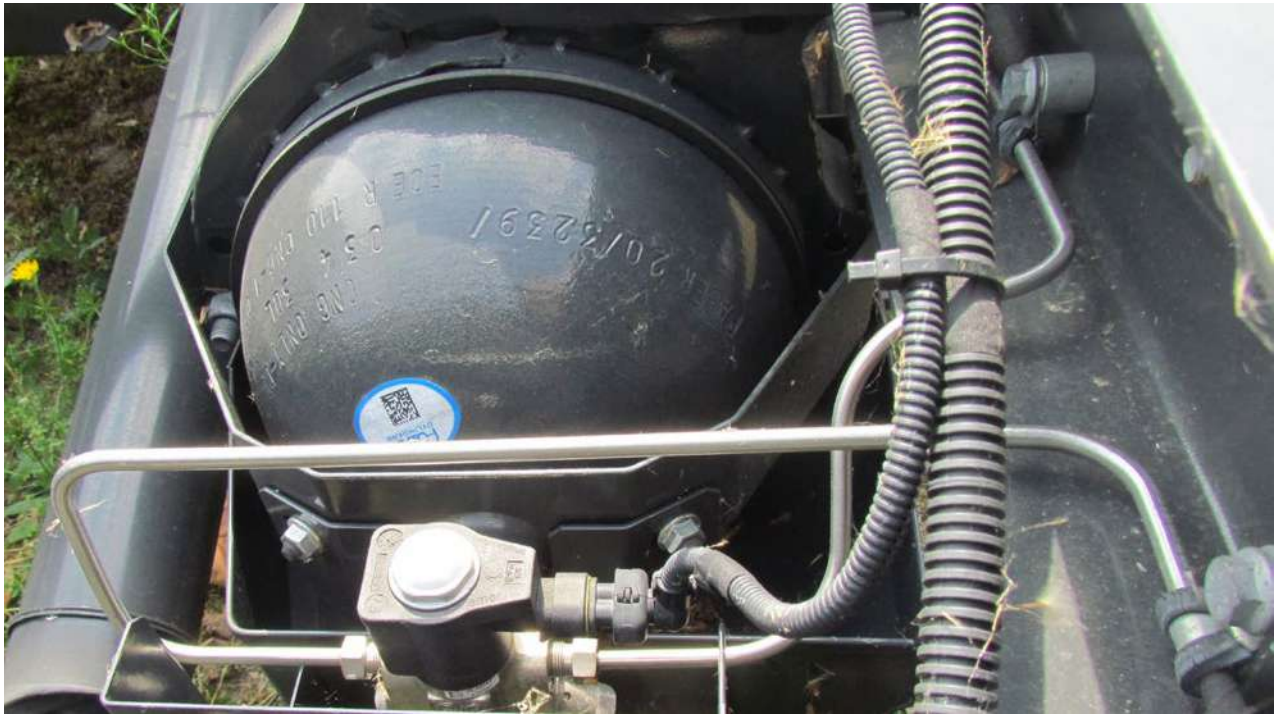
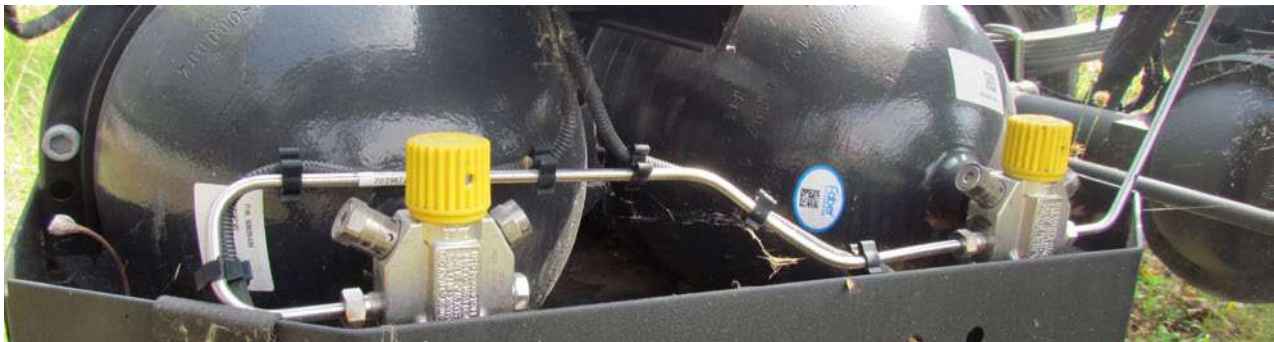
# Rigid lines for CNG cylinders

Rigid lines must be returned in proper conditions as illustrated in pictures.

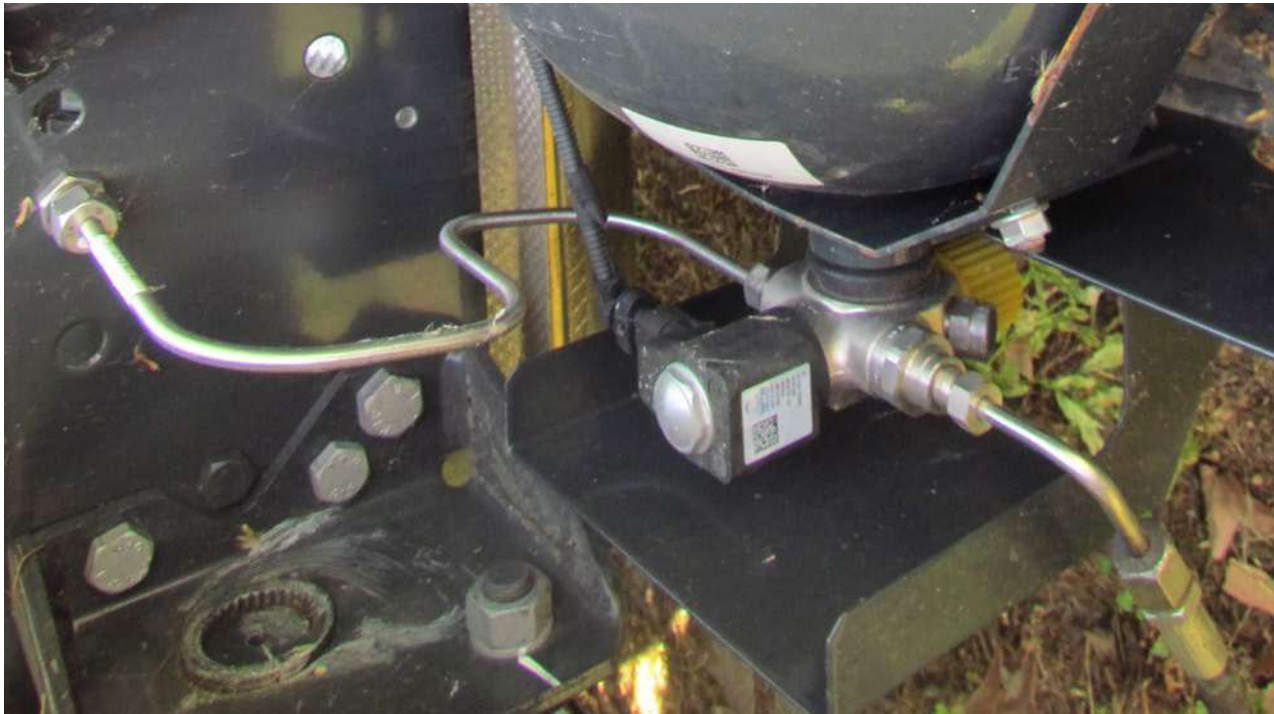
Rust, dents, breakages and/or gouges  
 • charge for replacement of rigid lines.

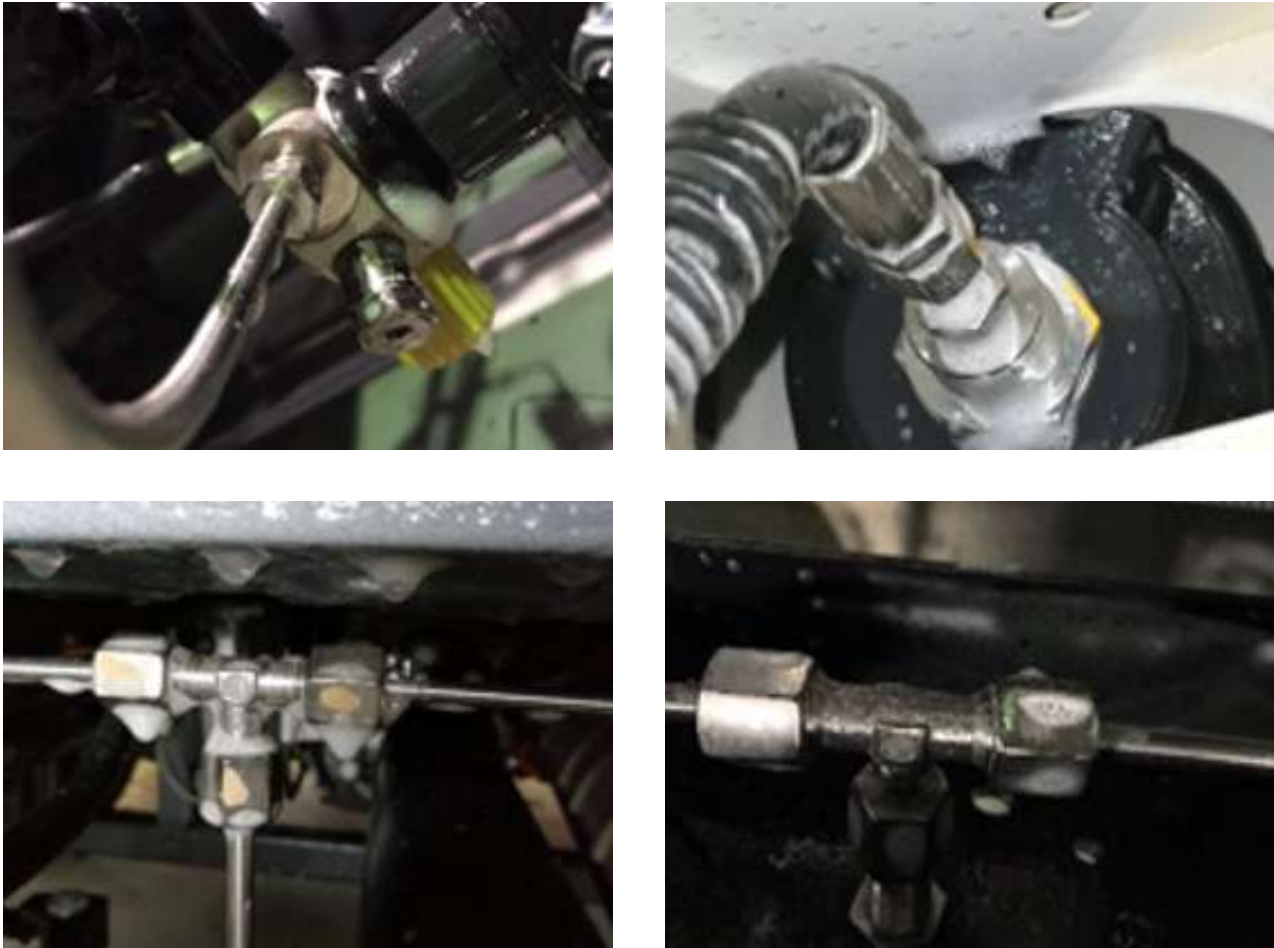
# Gas leakage detection

1. Use a spray leak detector
2. In the leakage warning area, apply on junction potentially involved specific product spray («1000 bolle»)
3. A leakage should generate bubbles like pictures in red section

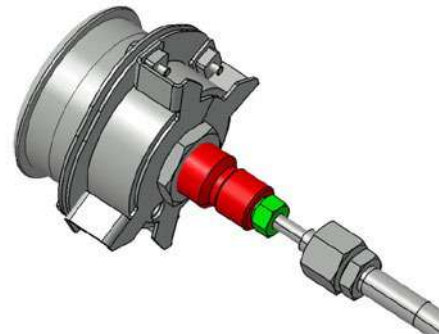
High-Pressure Hose  
Connection to Filler Inlet

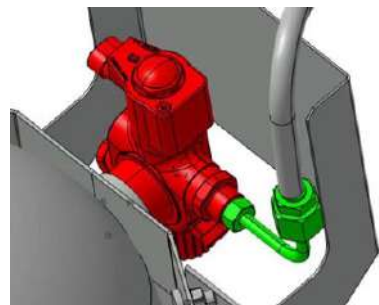
High-pressure hose connection to the check valve on the solenoid valve

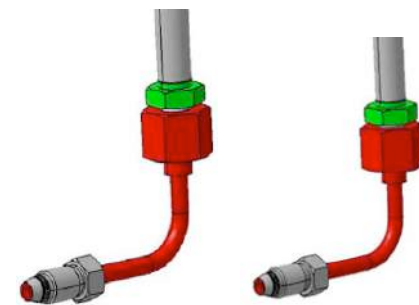
Fittings on high-pressure hose
