**IVECO**  
CERTIFIED PRE-OWNED

# Vehicle Return Guidelines

This damage catalogue aims to prepare you for returning your IVECO vehicle when your usage period comes to an end.

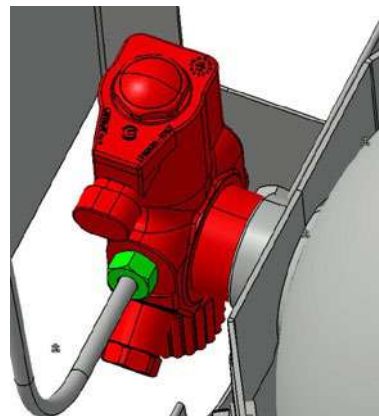
Connection of stainless steel rigid piping to solenoid valve

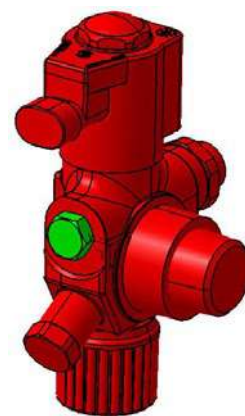
Blind plug on solenoid valve

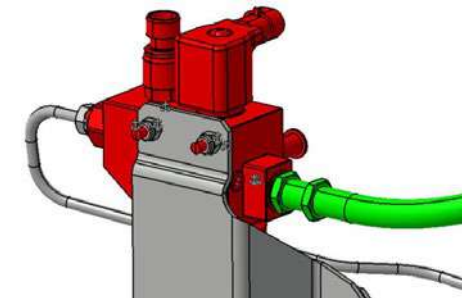
Medium-pressure hose connection to the pressure reducer

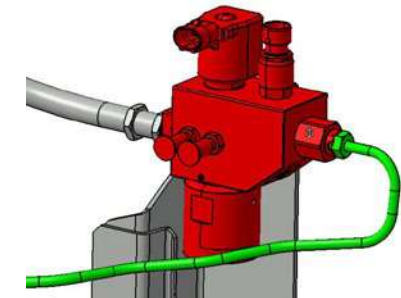
Stainless steel rigid pipe connection to pressure Reducer (Russia Market)

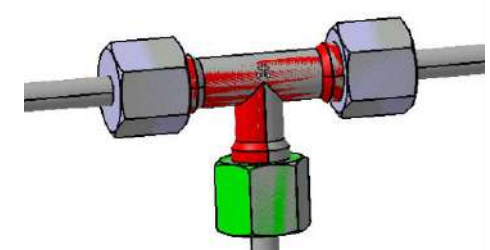
Fastening through coupling to chassis

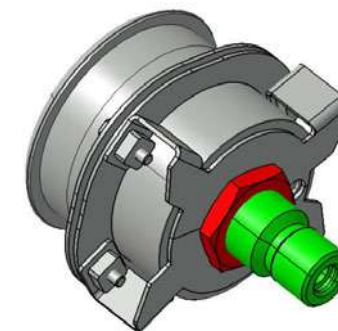
Stainless steel rigid pipe connection to "T" fitting Or through coupling

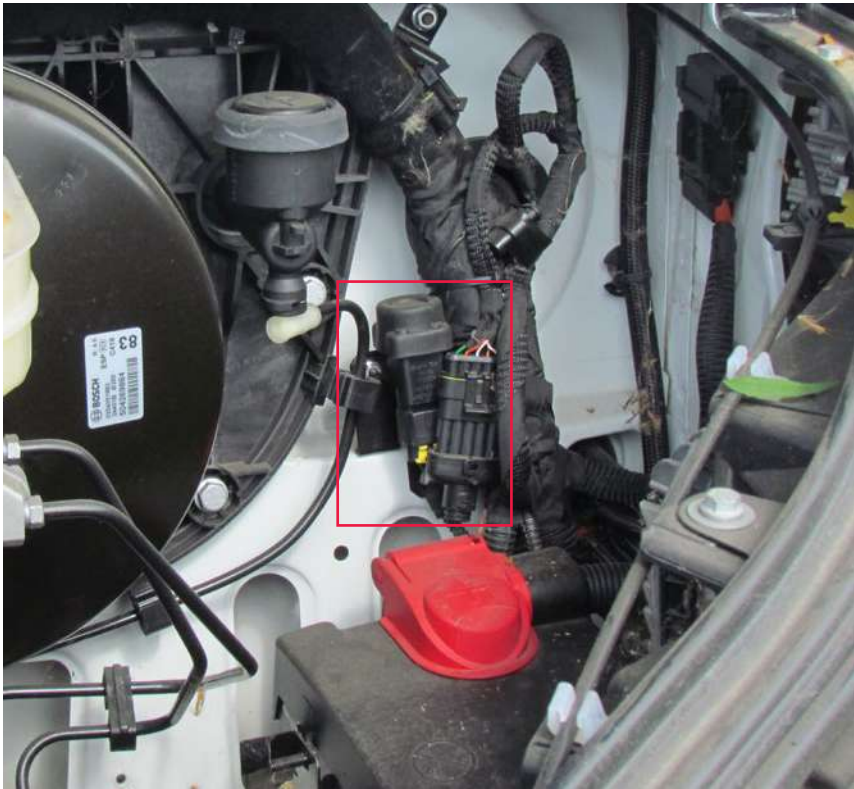
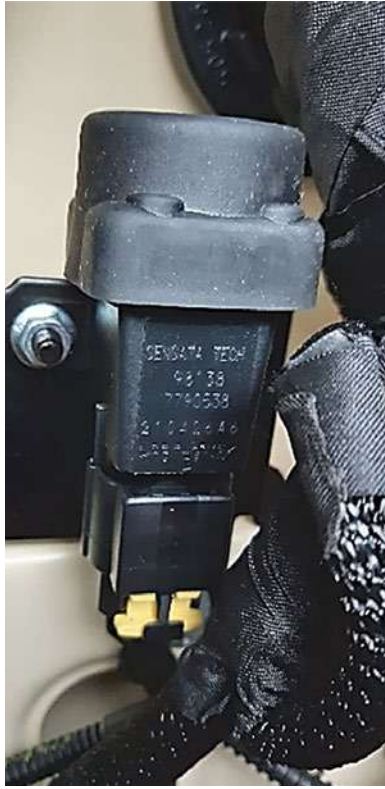
**FIS:**  
Inertial Safety Switch

- To remove electrical connection
- During key on, the Electro Valve (EV) must be remained off

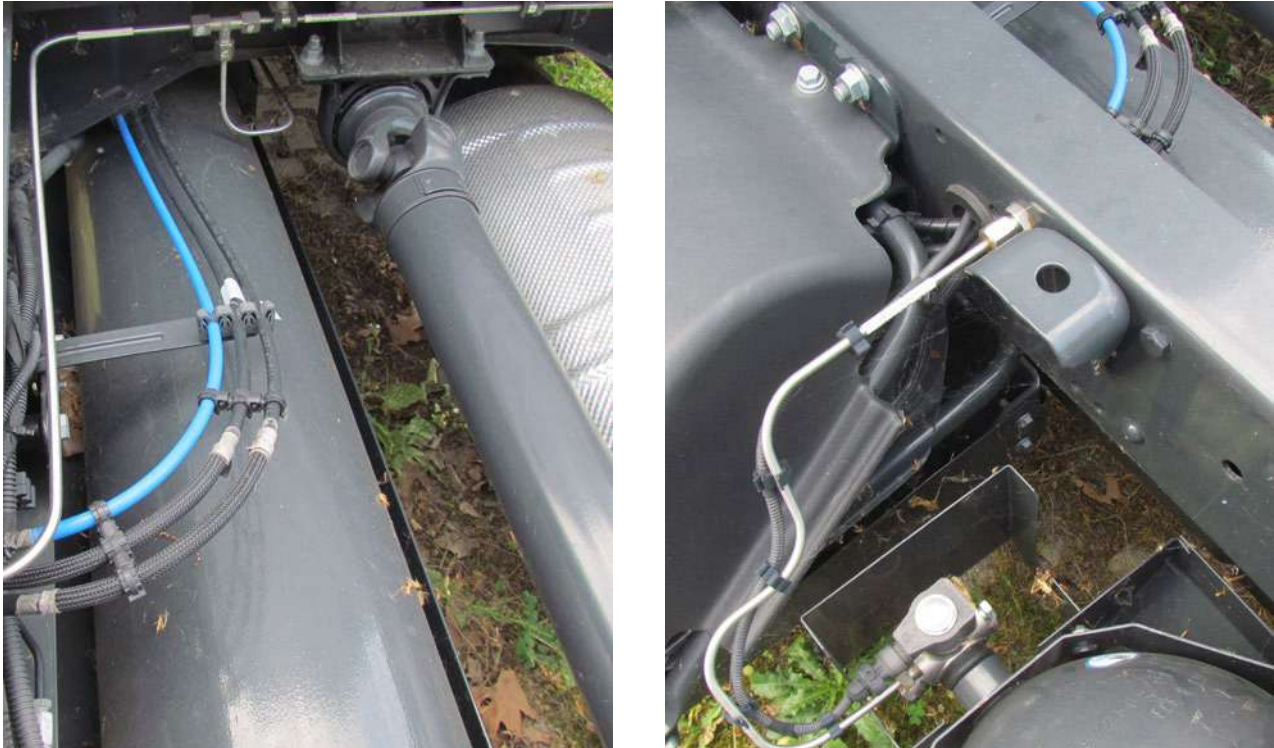
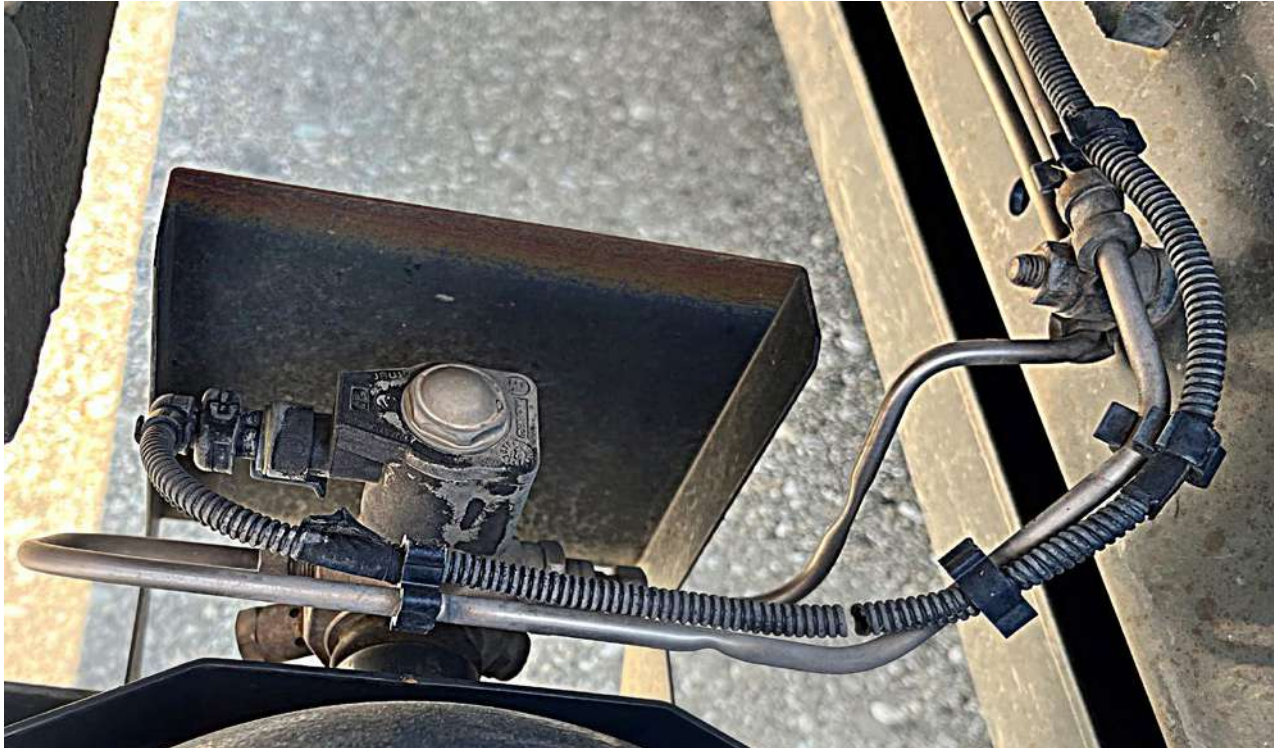
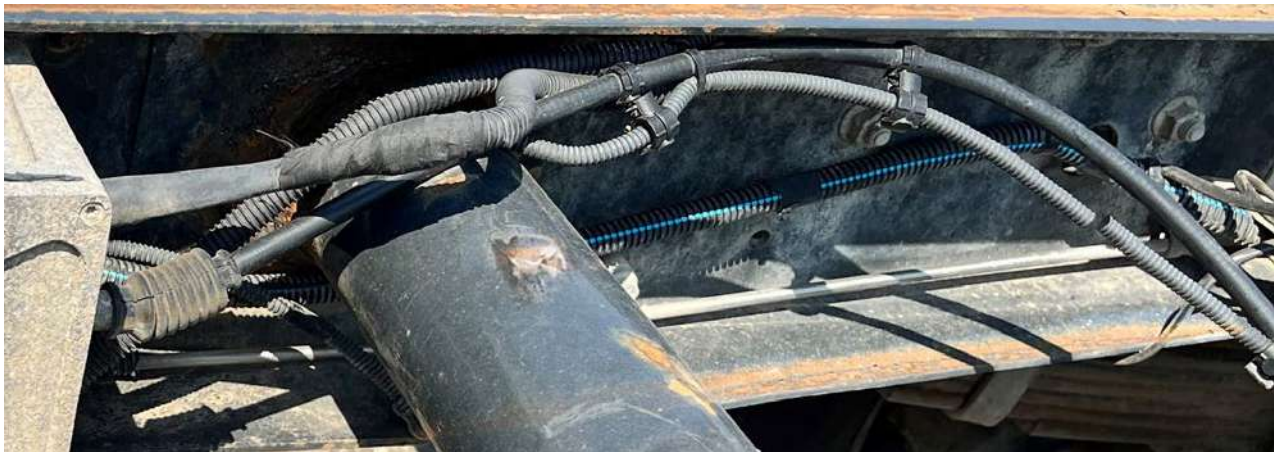
Check integrity of the gasoline fuel lines (no losses, no evidence of deep scratch). Fuel lines must be returned in proper conditions as illustrated in picture.

Losses or evidences of deep scratches

- charge for replacement of fuel lines.

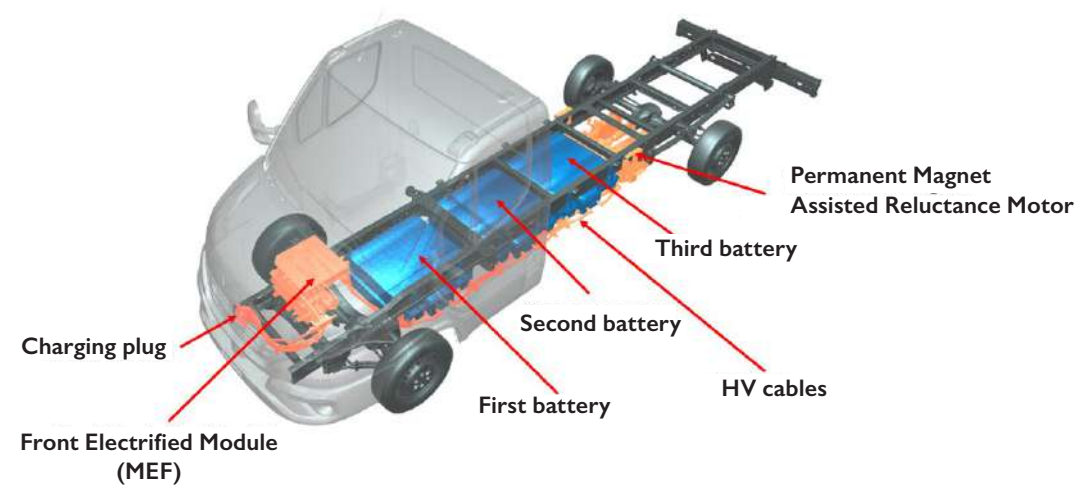
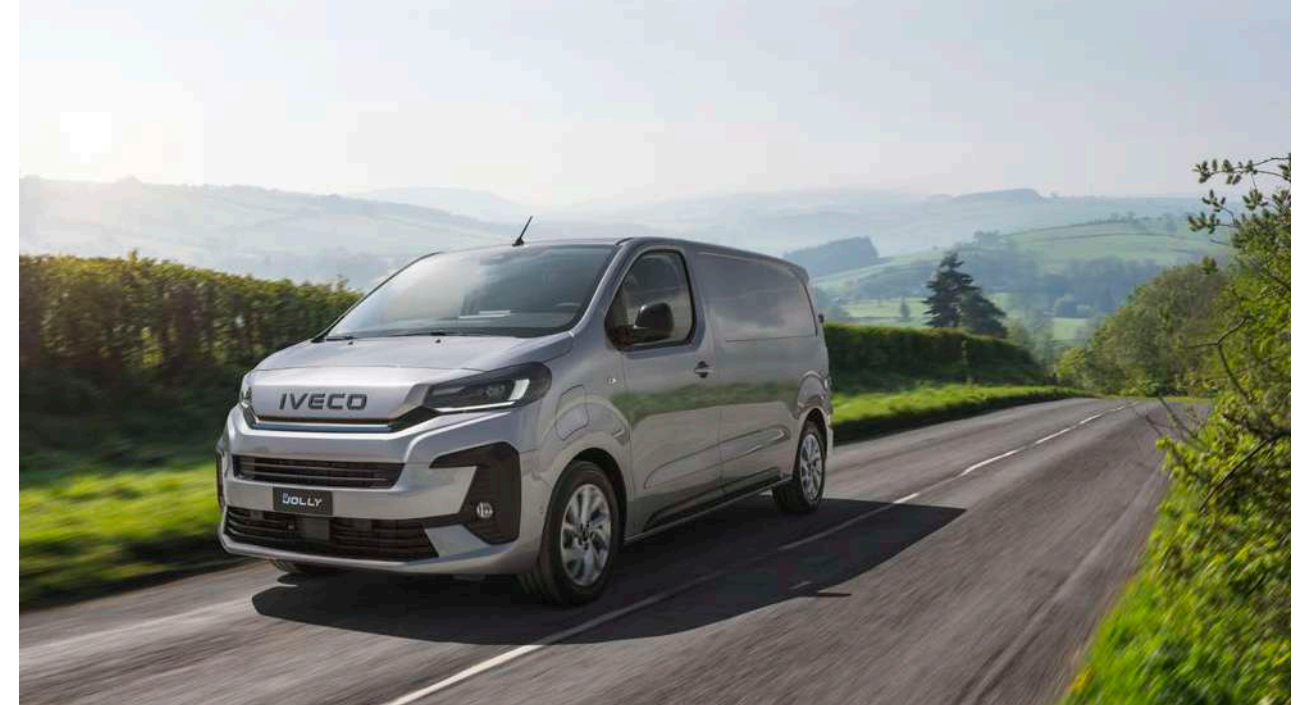
**eDaily** can be equipped with 1, 2, 3 or 4 modular batteries, and the configuration can be upgraded during vehicle life.

Example of an eDaily 3 modular batteries

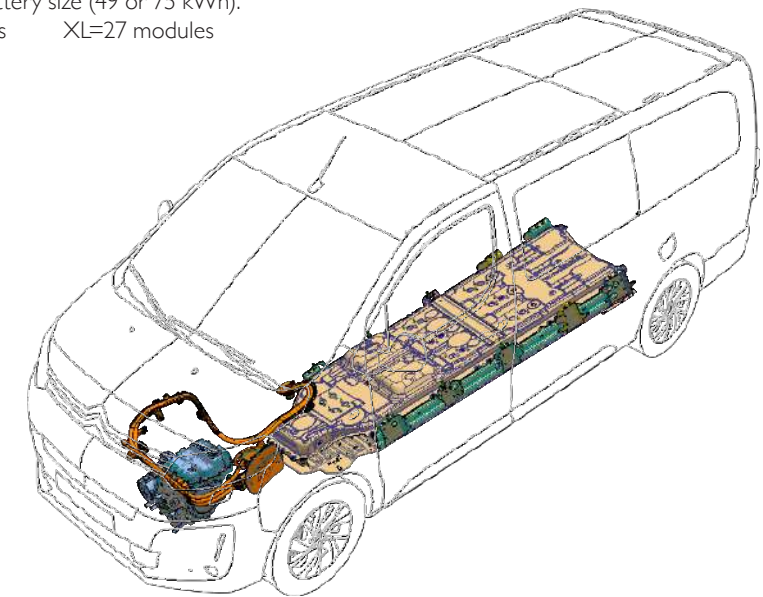
**eJolly** can be equipped with 2 battery size (49 or 75 kWh).  
Battery pack: S=15 modules XL=27 modules

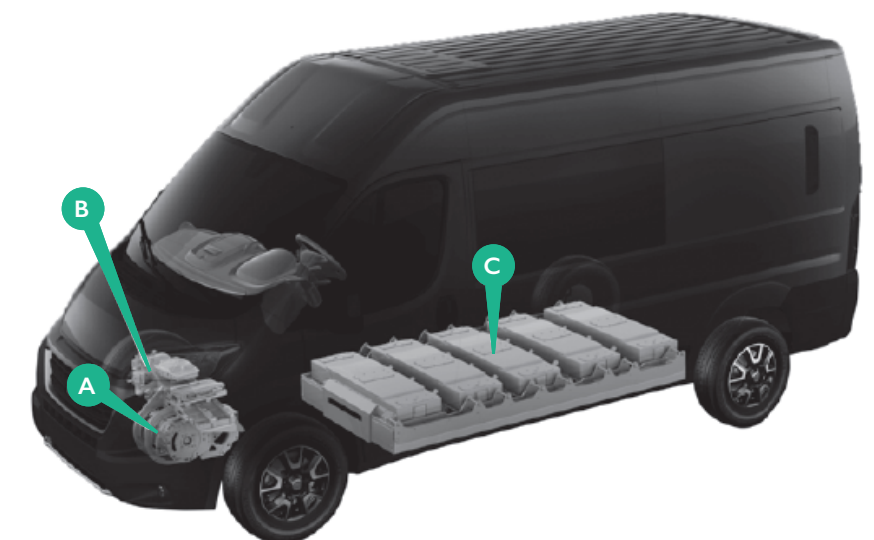
**eSuper Jolly** can be equipped with 1 battery up to 110 kWh.

A. Traction electric motor  
B. Voltage converter  
C. High-voltage batteries

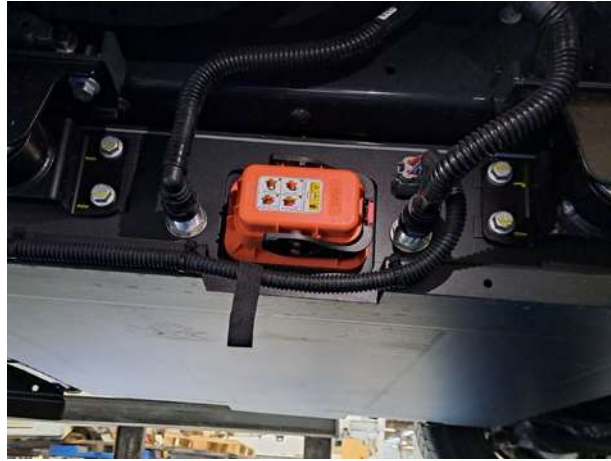
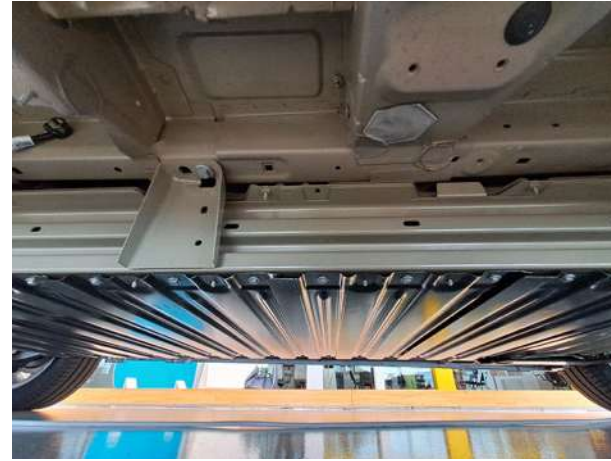
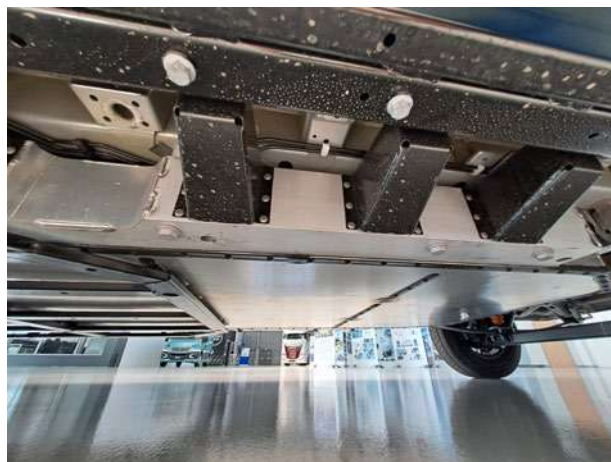
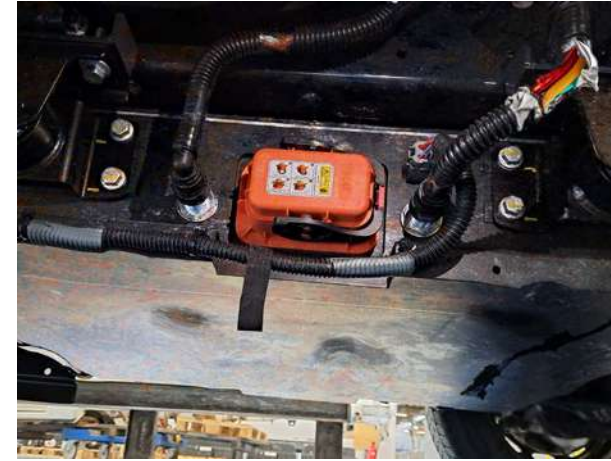
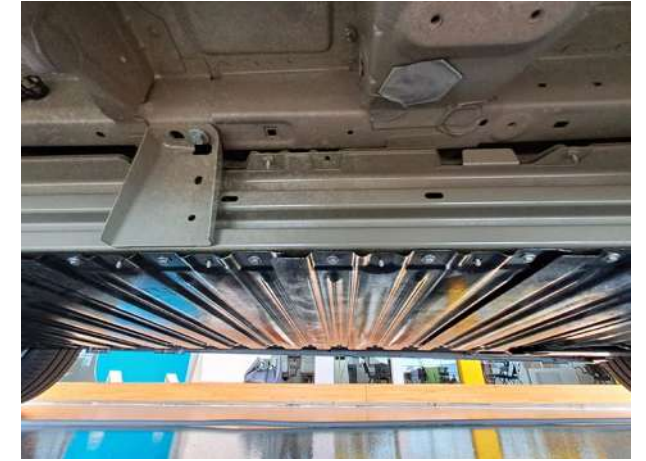
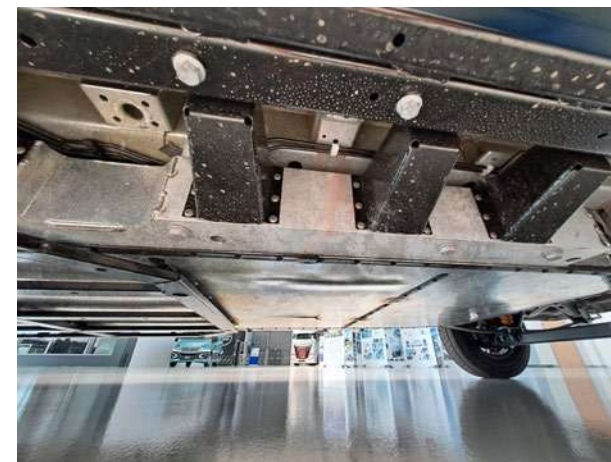
Pack battery protective covers must be returned in proper conditions as illustrated in pictures.

Visible dents and deformations that affect the functionality and/or safety

- charge for replacement of battery pack and protective covers.

Rust, corrosion, breakages and/or gouges that affect the functionality and/or safety

Liquid leakage and smell are not accepted.

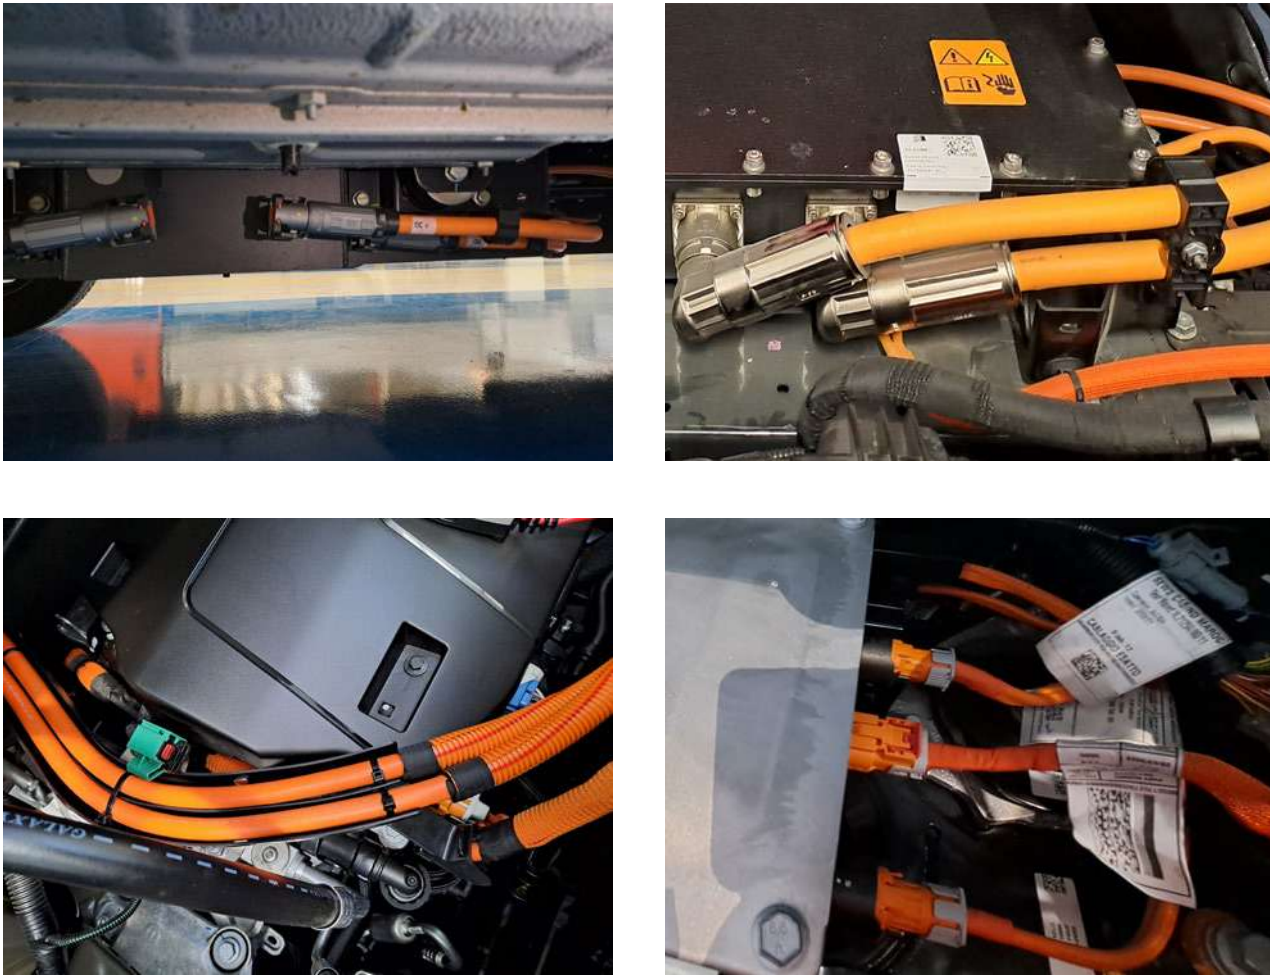
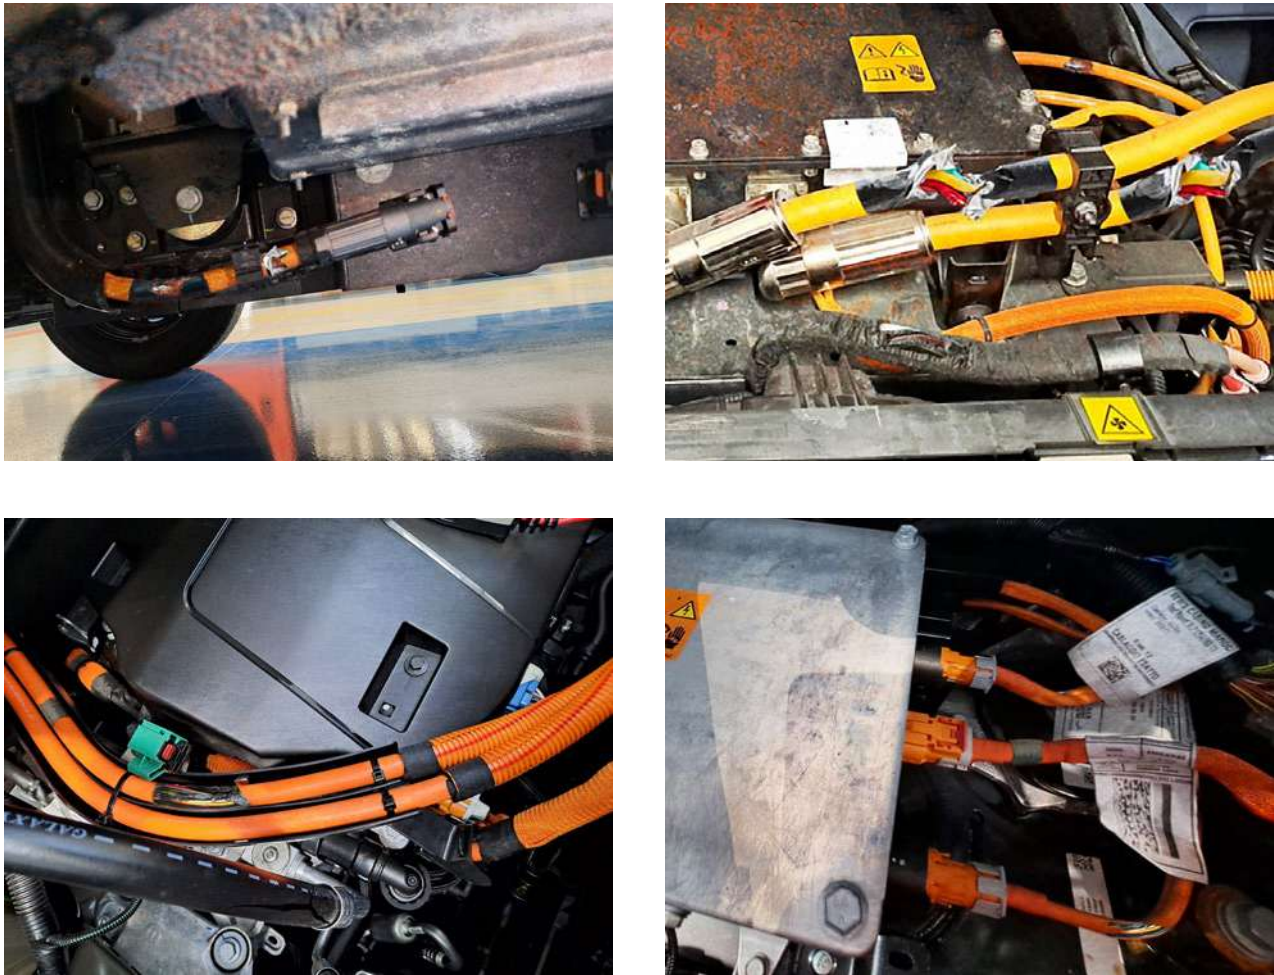
Check integrity of the high voltage cables and connectors (no evidence of deep scratch) both for battery pack and engine compartment.  
Cables and connectors must be returned in proper conditions as illustrated in pictures.

Evidences of deep scratches, cuts, gouges, abrasions:

- charge for replacement of high voltage cables and connectors.

Evidences of cable "burn-in", melted or discolored wires, exposed conductors:

- charge for replacement of high voltage cables

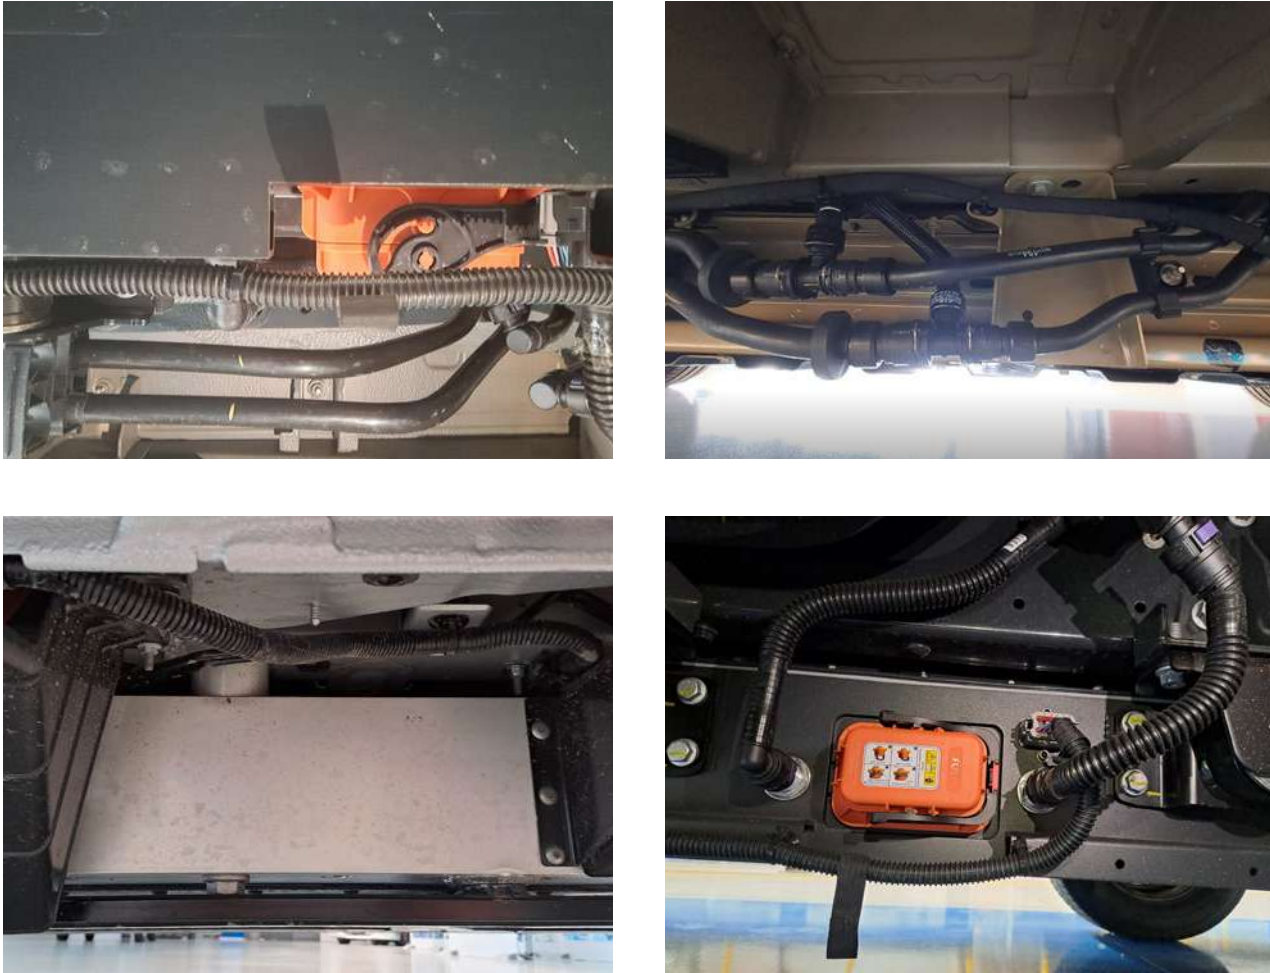
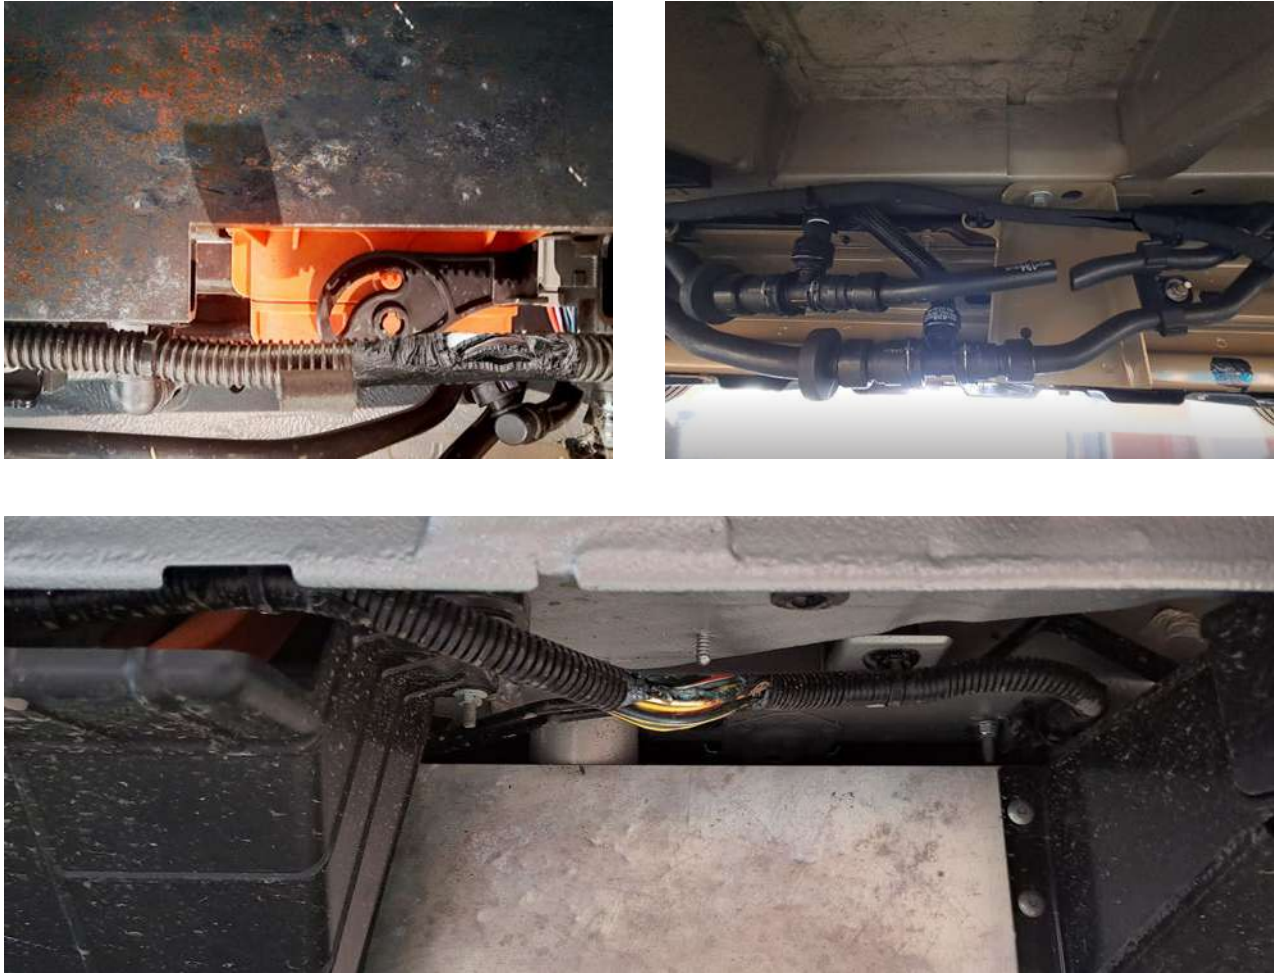
Check integrity of the low voltage cables and connectors (no evidence of deep scratch) both for battery pack and engine compartment.  
Cables and connectors must be returned in proper conditions as illustrated in pictures.

Evidences of deep scratches, cuts, gouges, abrasions:

- charge for replacement of low voltage cables and connectors.

Evidences of cable "burn-in", melted or discolored wires, exposed conductors:

- charge for replacement of low voltage cables.

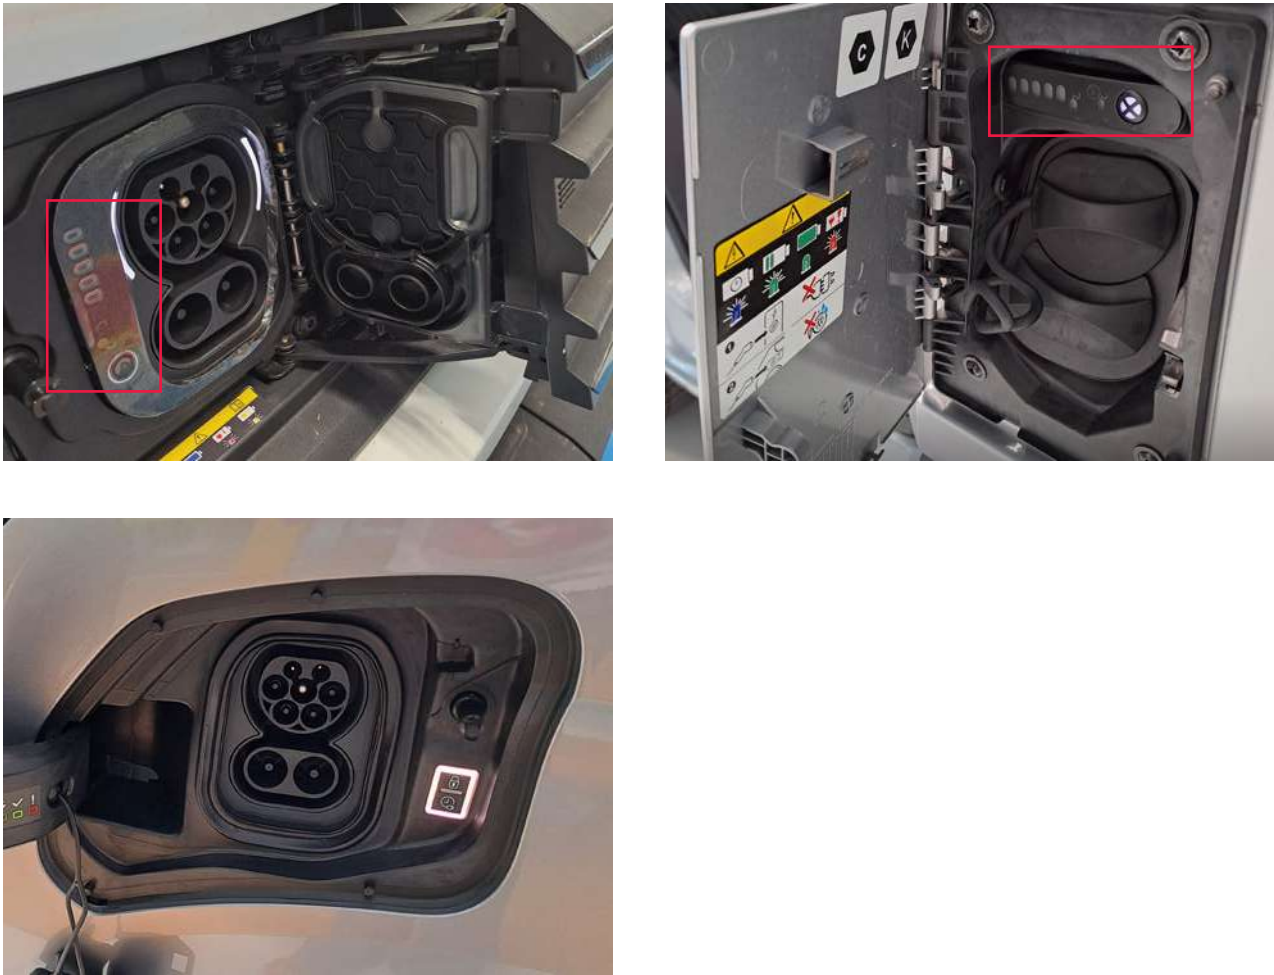
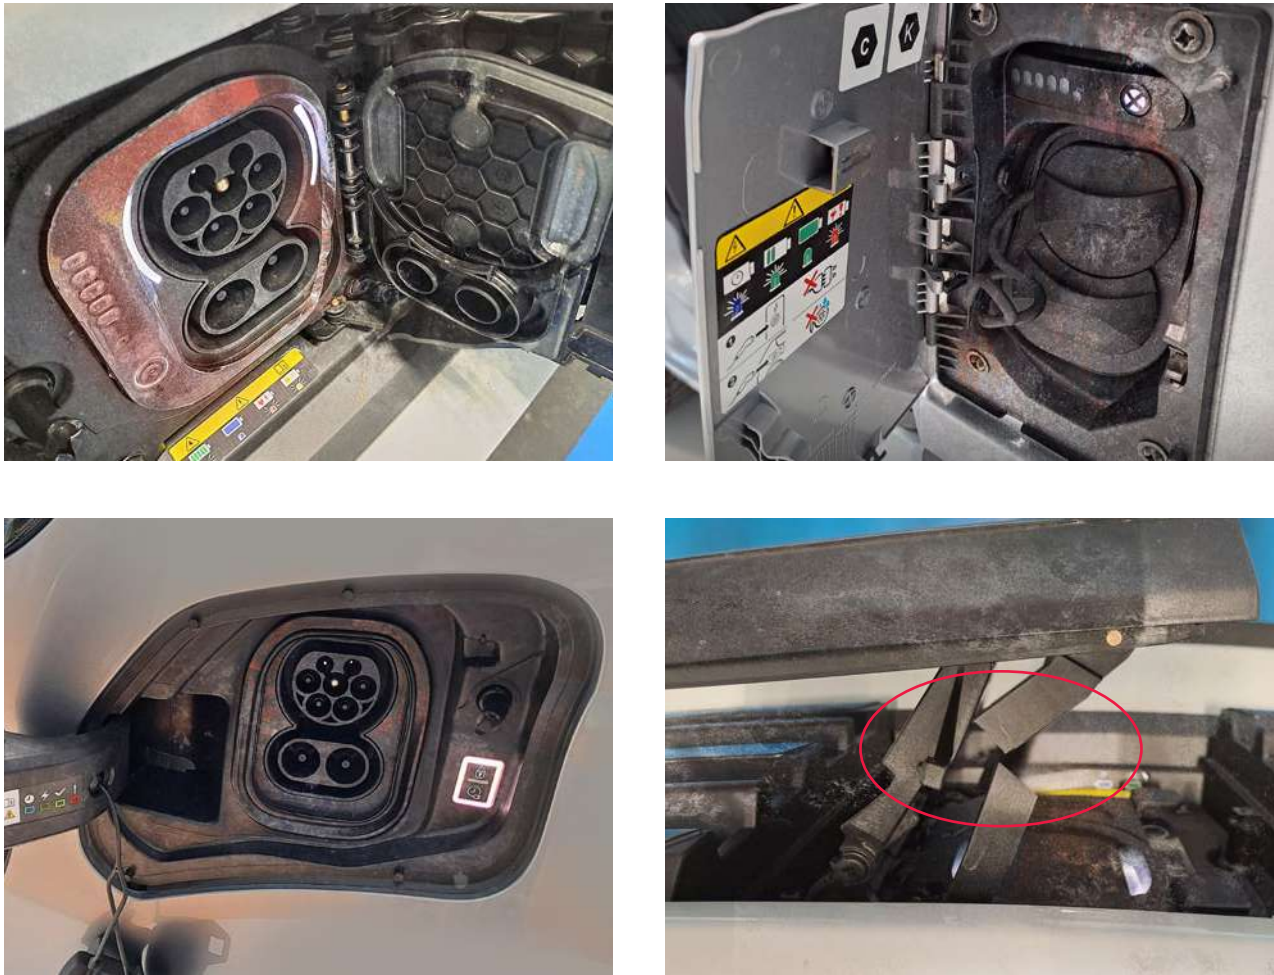
Check integrity of the charging socket and the interior and exterior flaps that cover and protect the socket (no evidence of deep scratch or plastic breakage).

Socket and flap must be returned in proper conditions as illustrated in pictures.

Check if there are any warning lights on to detect socket and vehicle anomalies (sections highlighted in red).

Visible dents and deformations or breakages that affect the functionality and/or safety

- charge for replacement of interior or exterior flap and socket.

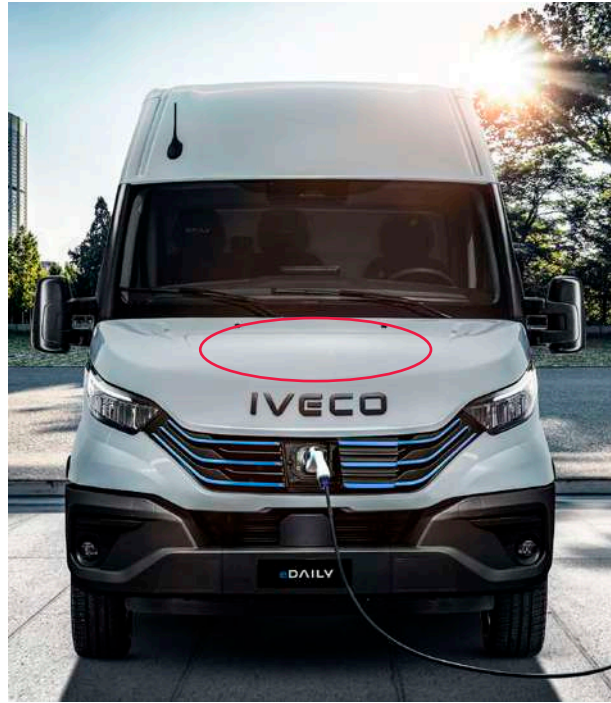
eDaily MEF Positioning

MEF Box, cable and connectors of engine compartment must be returned in proper conditions as illustrated in pictures and in previous sections.
